June 6, 2019

Re: Structural Building Review - Retired Sewer Pump Station
Ocean Ave. (Between Park Place Ave. and Ocean Park Ave.)
Block 99, Lot 1
Bradley Beach, Monmouth County, New Jersey
MC Project No. 19004172G

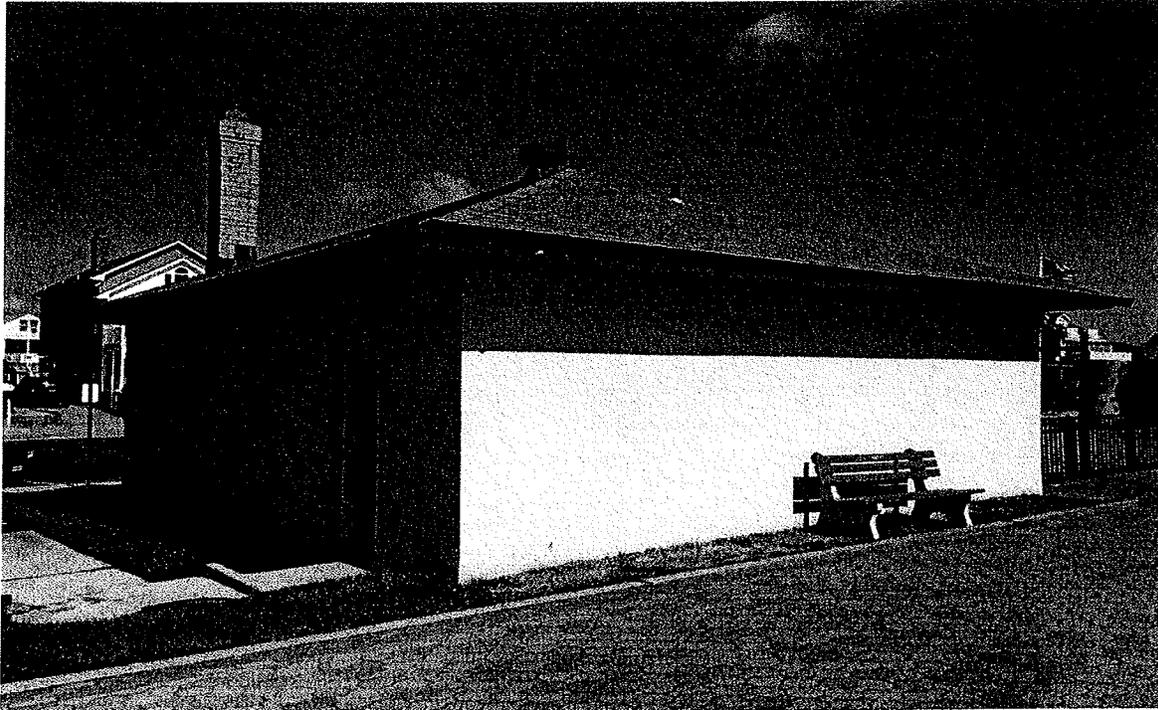
The building is located on the East side of Ocean Avenue along the boardwalk between Park Place Avenue and Ocean Park Avenue in Bradley Beach. It is a one-story rectangular shaped structure with an approximate footprint of 25'-0"x30'-0" (see Photo A&B). Currently the building is unoccupied, but based on information provided to our office, its original purpose was a sewage pump station.

(Photo #A) East Elevation Looking Northwest

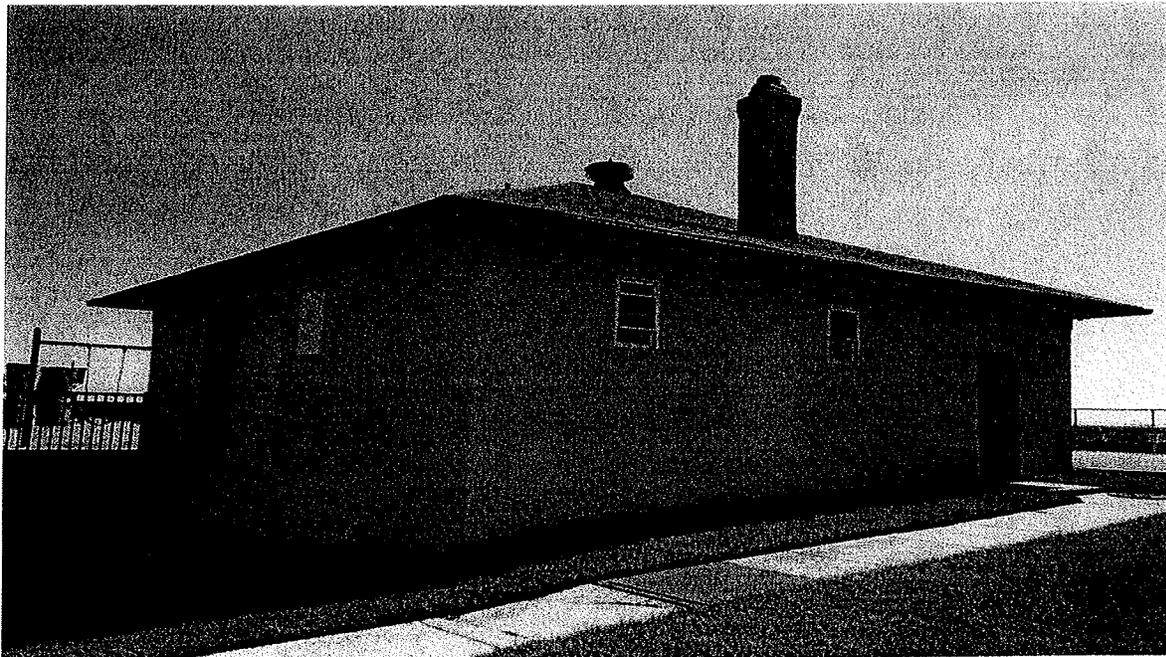
(Photo #B) South Elevation Looking Northeast

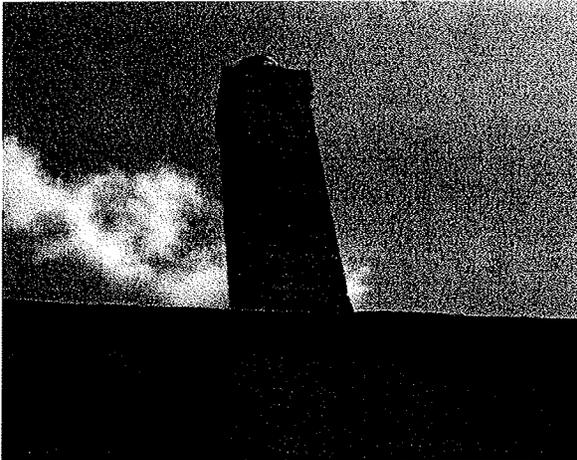
On the South side of the roof is a masonry chimney. The masonry and joints in the chimney are deteriorated and need to be rebuilt (see photo #3). On the interior of the building we observed that the chimney is not currently in use (see photo #4).

(Photo #3) Chimney

The chimney on the South side of the roof needs to be rebuilt. Since the chimney is not in use and if the future renovation does not require the chimney, it is recommended that the chimney be removed. The hole in the roof at the removed chimney should be patched in with new roof decking and shingle roofing.

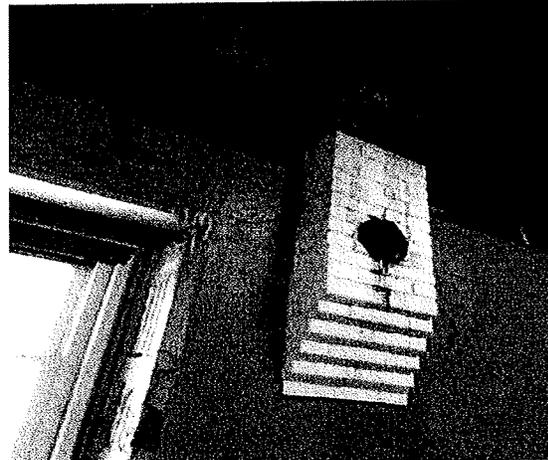
(Photo #4) Interior of Chimney Base

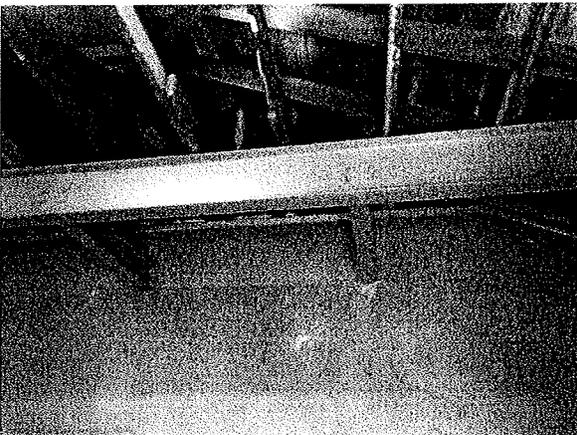
Below the ceiling framing are three (3) steel beams located on the East side of the building (see photo #5). The beams bear on the interior walls but do not support the roof or ceiling framing. The beams appear to have been part of some internal trolley system that is no longer in use.

(Photo #5) Ceiling Steel Beams

The existing steel ceiling beams on the East side of the building do not appear to be in use. The three steel beams may be removed without any impact to the building structure. In addition, if the interior walls are removed below steel beams, the steel beams will need to be removed prior to removing the walls.

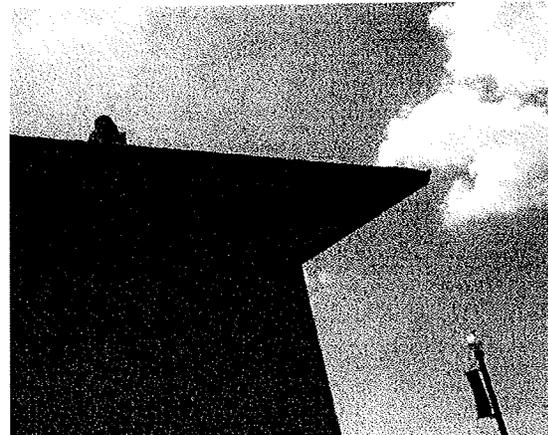
It was noted that the roof gutter leaders on the exterior of the building have all been removed (see photo #6). Further information should be provided from the Town to determine why the leaders were removed. New leaders should be installed to properly drain the storm water from the roof.

(Photo #6) Missing Corner Gutter Leader

New roof gutter leaders should be installed for proper roof storm water drainage. The Town should verify why the leaders were decided to be removed in the first place.

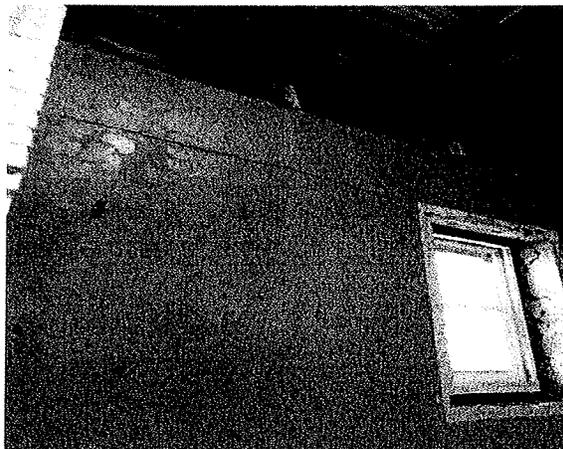
Cracks were observed on the interior faces of all exterior walls. The majority of the cracks appear to be emanating from the heads of the window and door openings in the walls (see photo #7). Upon further review, the existing steel lintels over the openings were observed to be rusting (see photo #8). The rust is caused by the stormwater and the ocean environment. Other crack locations on the inside face of the exterior walls seem to be located at embedded conduits that are rusting (see photo #9). The exterior stucco finish appears to be in good condition with only some minor niches and damages at wall opening jambs (see photo #10).

(Photo #7) Cracking from Window

It is recommended that the rusted steel lintels over the window and door openings in the exterior walls be removed and replaced with pre-cast concrete lintels. The roof framing above the openings will need to be shored prior to removing the lintels. After the lintels have been replaced the cracks on the interior faces of the walls should be patched and mortared solid. If the existing wall openings are not to be used, the lintels should still be removed, and the openings should be filled solid with CMU. If the future renovation requires the existing wall openings to be enlarged, the lintels can be replaced with new longer lintels and the opening’s sill may be lowered by cutting and removing the wall to a new sill elevation. Any embedded rusted conduit on the interior side of the exterior walls should be removed and the cracks due to the rusting conduits should be patched and mortared solid. Any repair or modifications of the interior side of the wall will require patching the plaster finish. Any exterior stucco finish with niches and damages should be patched.

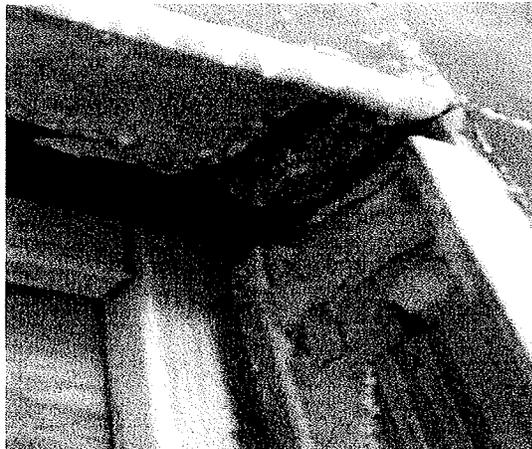
(Photo #8) Rusted Lintel

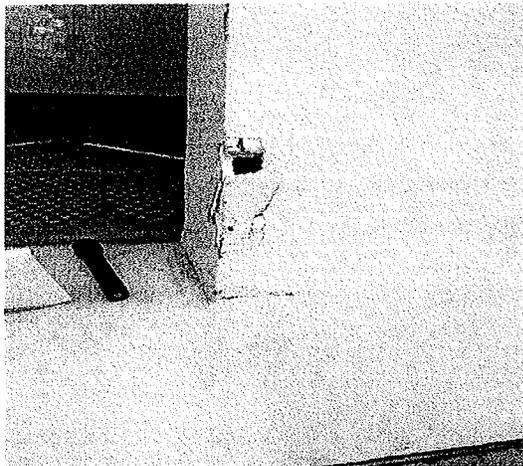
(Photo #10) Damage to Stucco

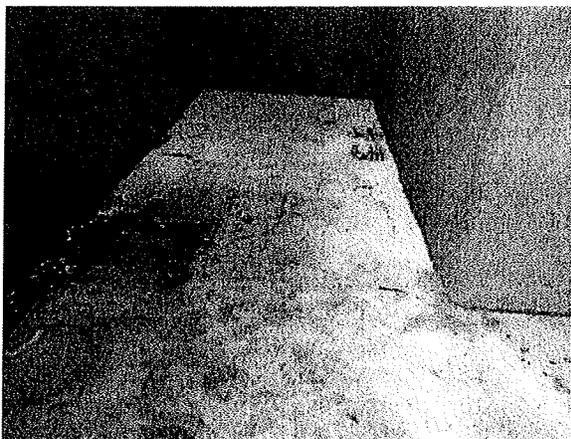
The floor slab appears to be in sufficient condition. Minor cracking was noticed at one area of the floor slab, but those appears to be within a topping slab that was placed over the floor slab (see photo #11). The first floor contains several circular pipe openings (see photo #11) and rectangular hatch openings (see photo #12). The hatch openings have steel plates over the openings and most of the pipe openings were filled in the concrete. At the hatch openings, the steel plates can be removed, and the opening can be filled solid with a new slab. Any open pipe penetration can be filled solid with concrete.

(Photo #11) Crack in Slab and Pipe Penetration

The cracking on the top surface of the slab appears to be in a leveling concrete that was poured over the original floor slab. The cracks can be patched or if the cracks are excessive the leveling concrete can be removed and replaced. If required as part of the future renovation, the existing floor openings at the hatches and pipes can be infilled. The infill of the hatch openings would include bolting new steel angles to edges of the concrete on all sides of the opening, installing a

form deck between the angles and then pouring a reinforced concrete slab in the form deck. The infill of the pipe openings would include removing any abandoned pipes and filling the pipe opening with new concrete. Temporary formwork may be necessary on the underside of the existing slab to hold the new concrete infill.

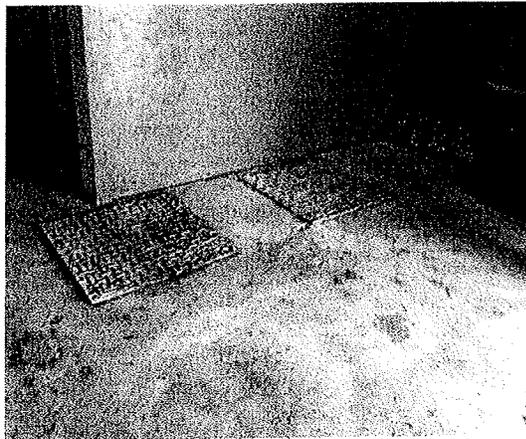
(Photo #12) Floor Hatches
