RE: Irvington Manor LLC
217 McCabe Avenue
Bradley Beach, NJ 07720
Block: 37, Lot: 2

STRUCTURAL SAFETY CONDITION FIELD REPORT

The purpose of this report is to determine degree of fire damage and structural stability of the entire building framing system and to determine possibility for continuation of use.

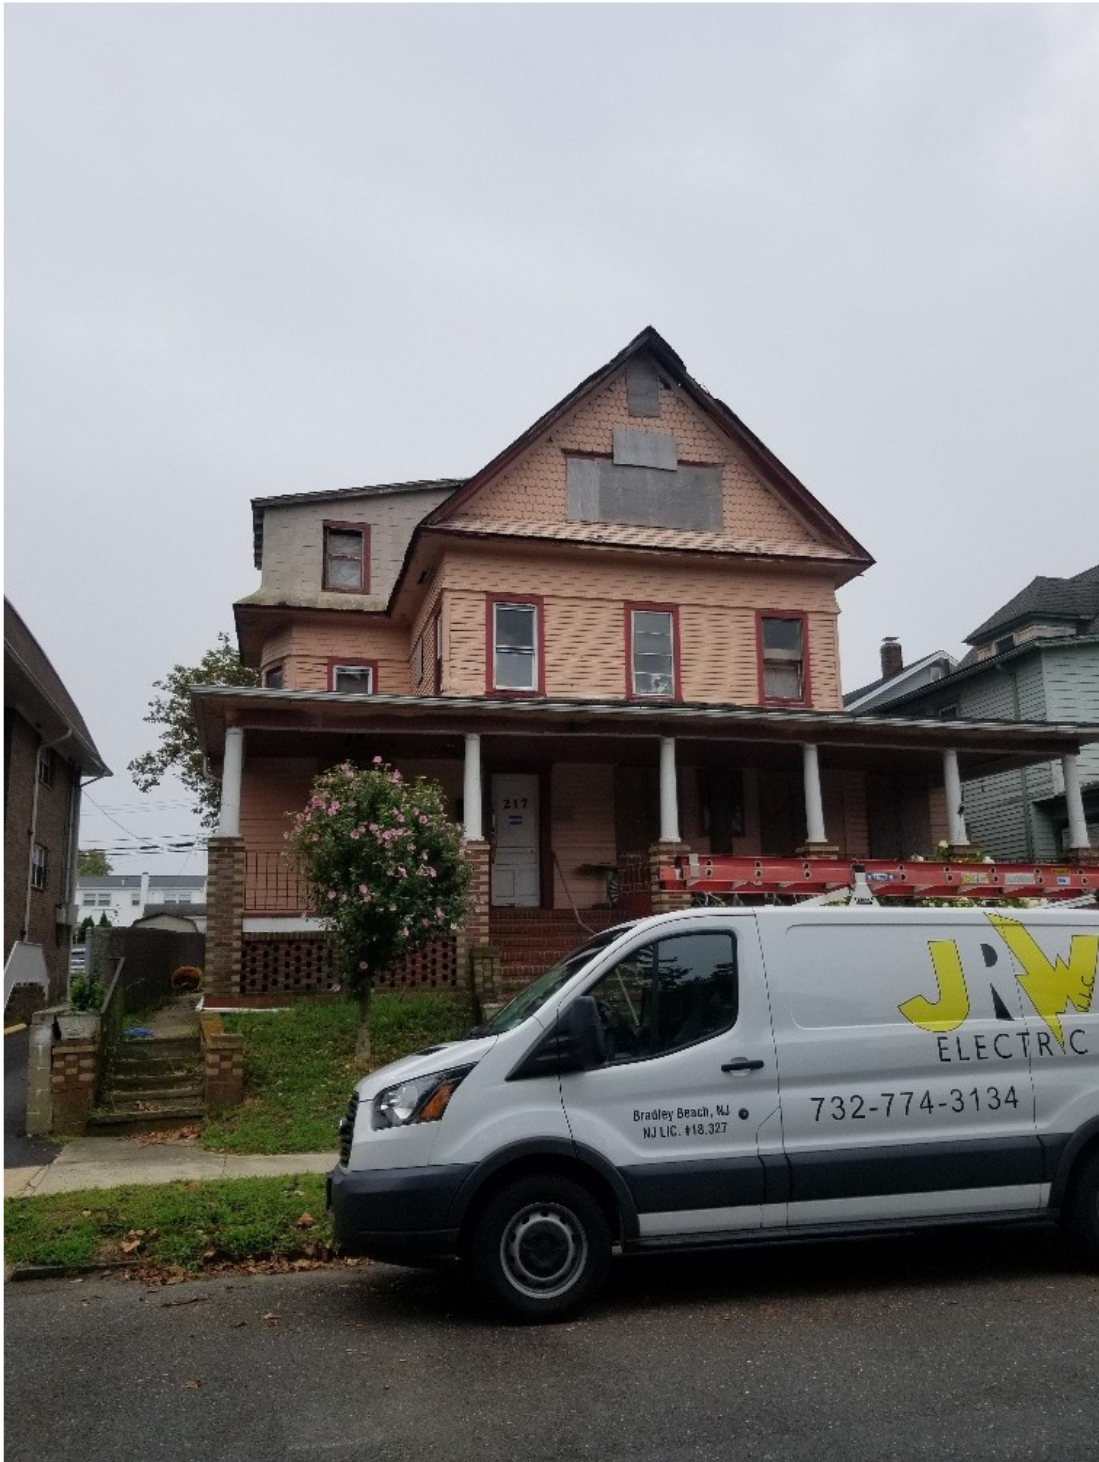
Building façade finished in mixture of cedar shingles, siding and roof shingles has been deteriorated during years of unkempt but still mostly weather tight. The front roofed terrace wood plank ceiling in need of repairs and terrace concrete tile floor cracked and cave in due to uneven settlement of the foundation. The Bilco cellar access door is missing and entrance covered with plywood. The structure still safe but in need of repair. See photos ##1, 2, 3,5,6,7 and 8.

1. Exterior view –Front elevation

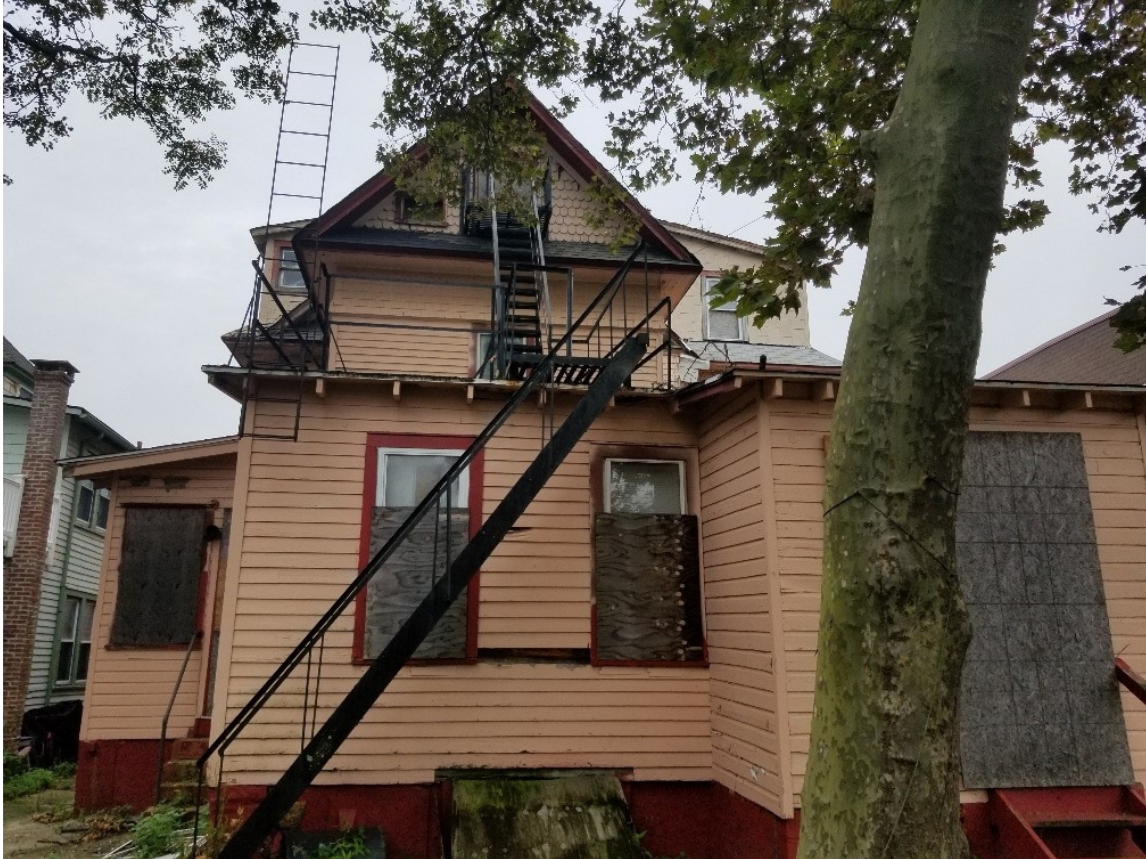
3. Exterior view –Rear elevation

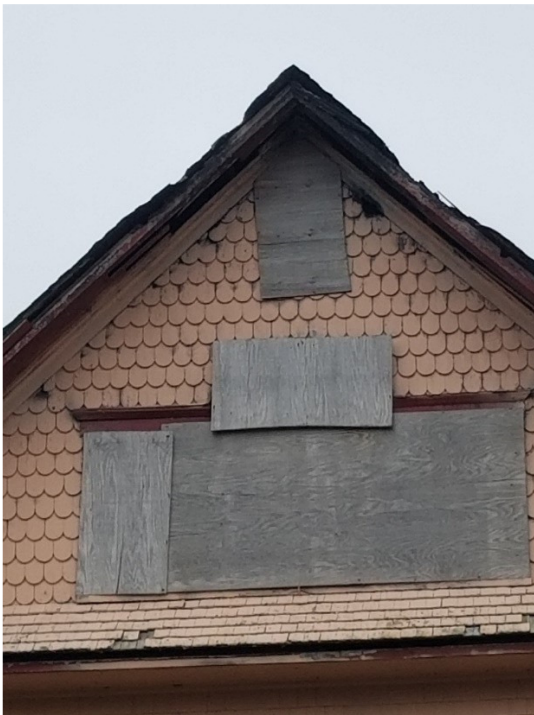
3. Exterior view –Façade siding and Fire damage

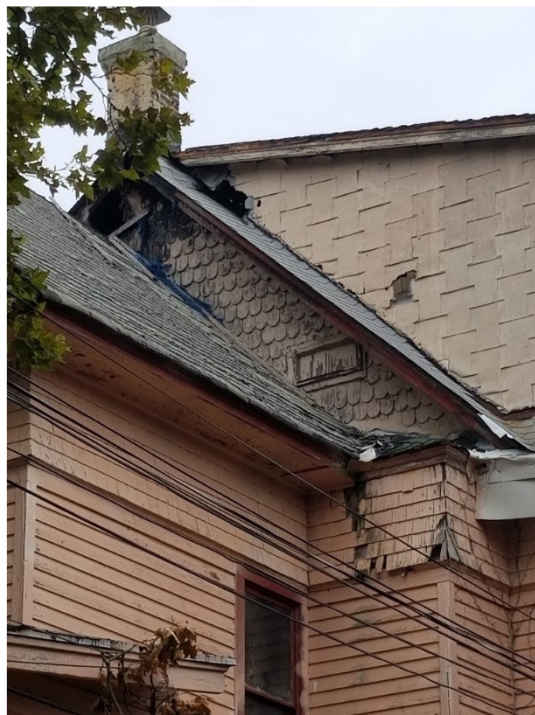
4. Exterior view –Façade siding and Fire damage

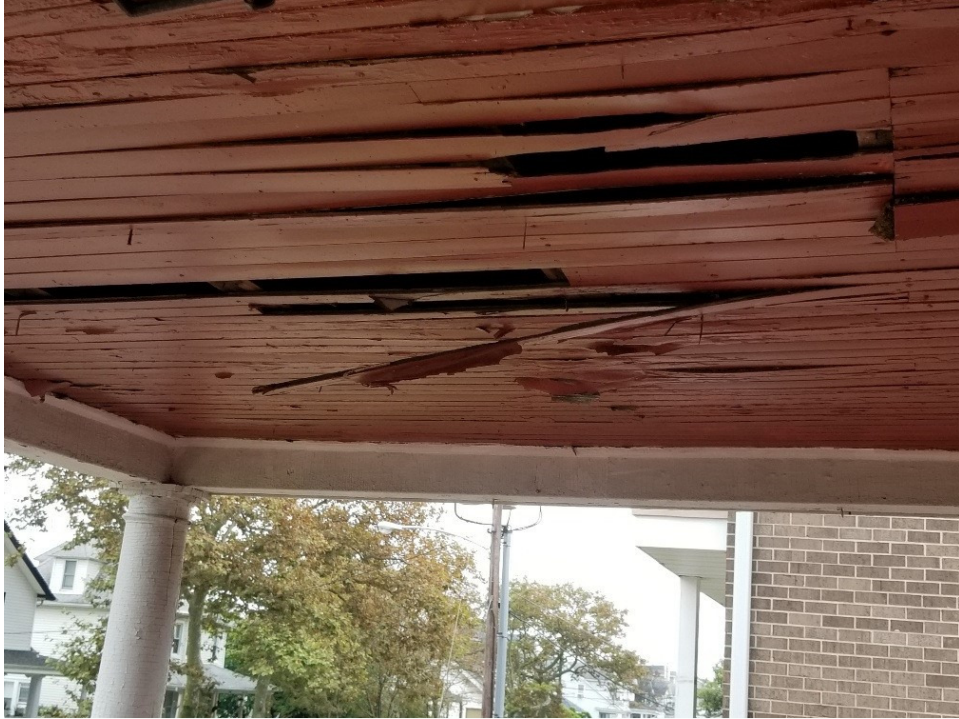
5. Exterior view –Ceiling at roofed terrace

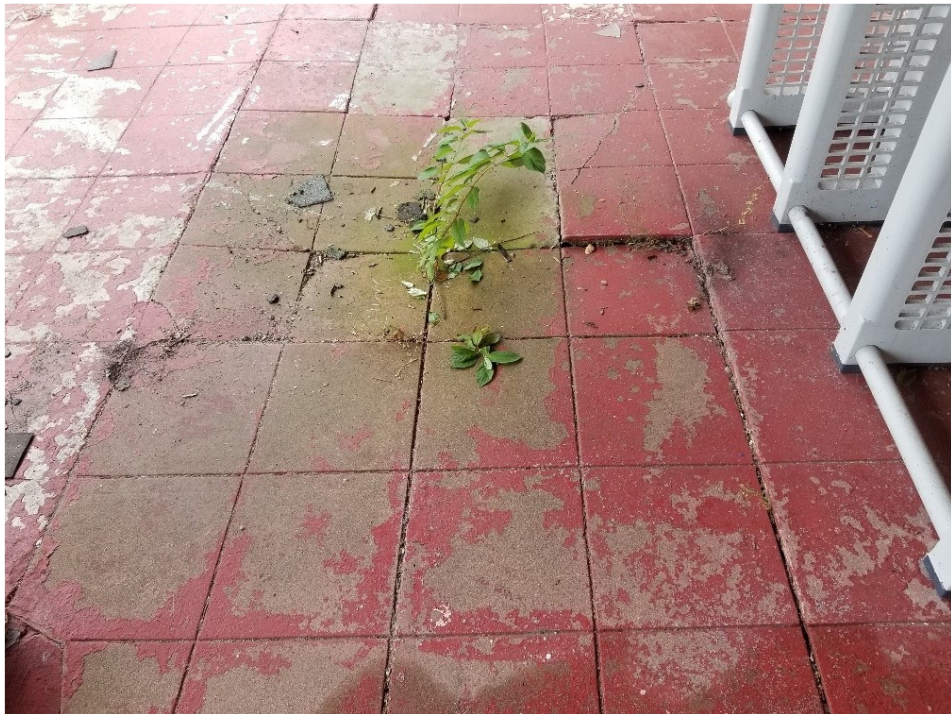
6. Exterior view –Floor at roofed terrace

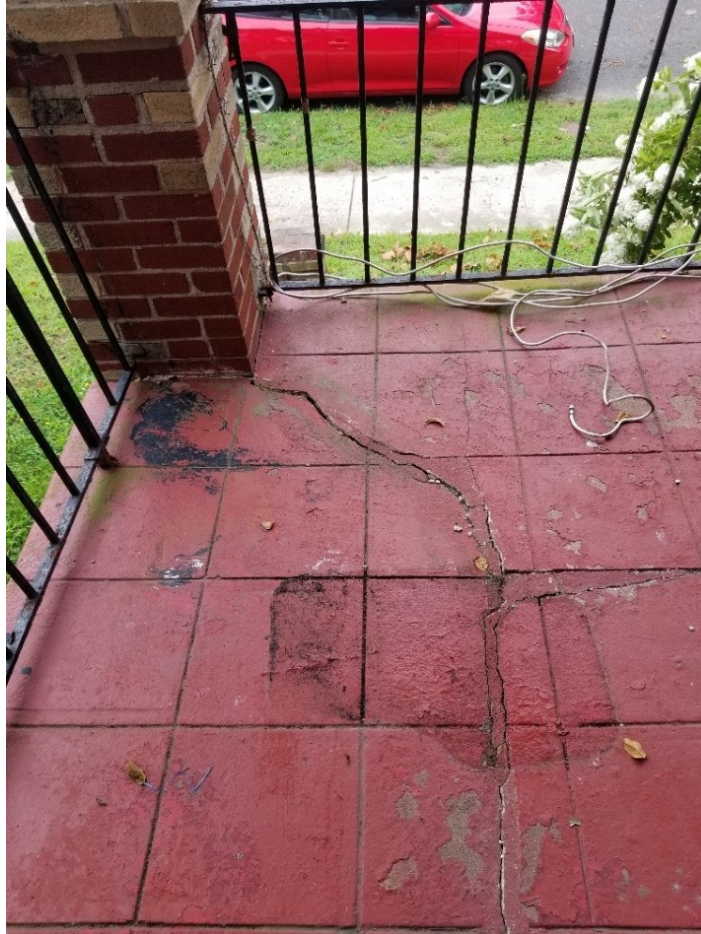
7. Exterior view –Floor at roofed terrace

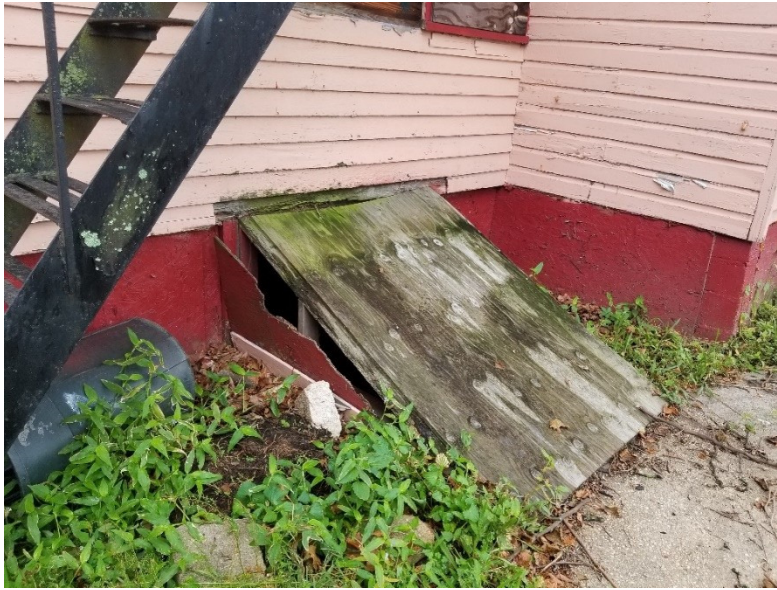
8. Exterior view –Missing Bilco door

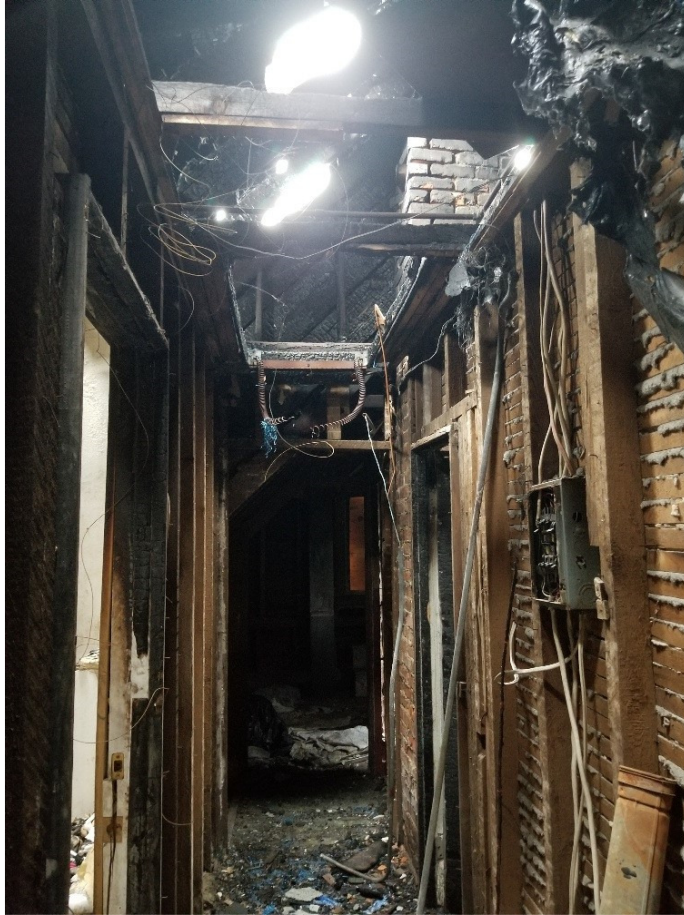
The roof is non-uniformly framed with 2"x 6" and 2"x 4" roof rafters spaced at 16" on center and mixture of plywood and wood plank sheathing. Roof sustained fire damage in an area around chimney with about 22% of roof rafters damaged beyond repair along with roof sheathing and other 78% still be in use. See photos ##9, 10, 11 and 12.

9. Attic floor –Fire damage to roof rafters, partitions still intact

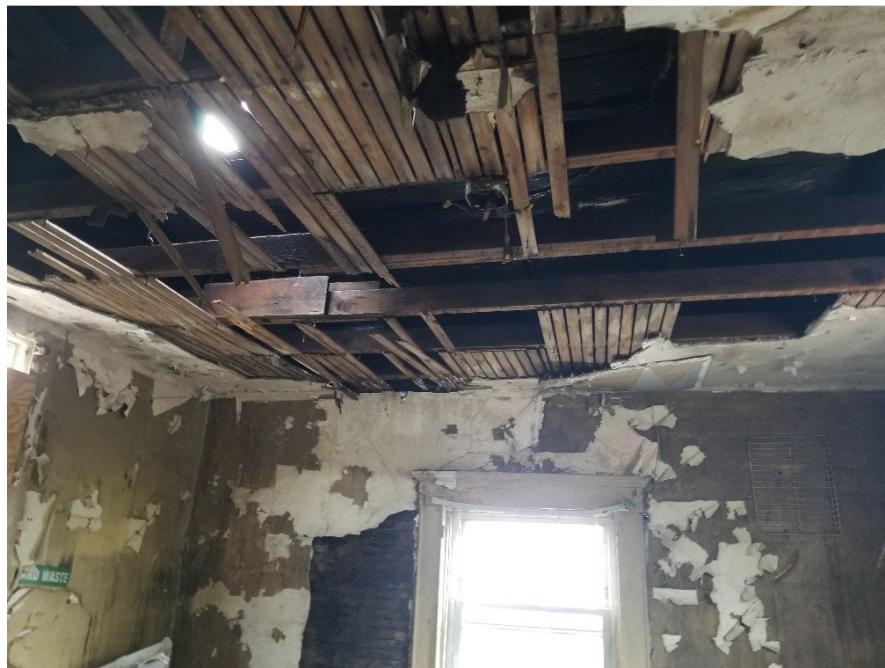
10. Attic floor –Fire damage to roof rafters, partitions still intact

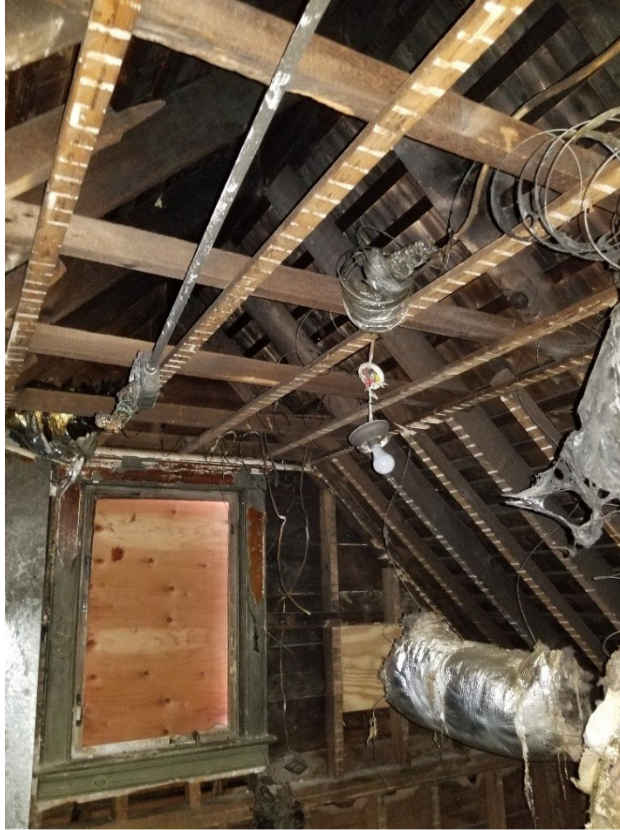
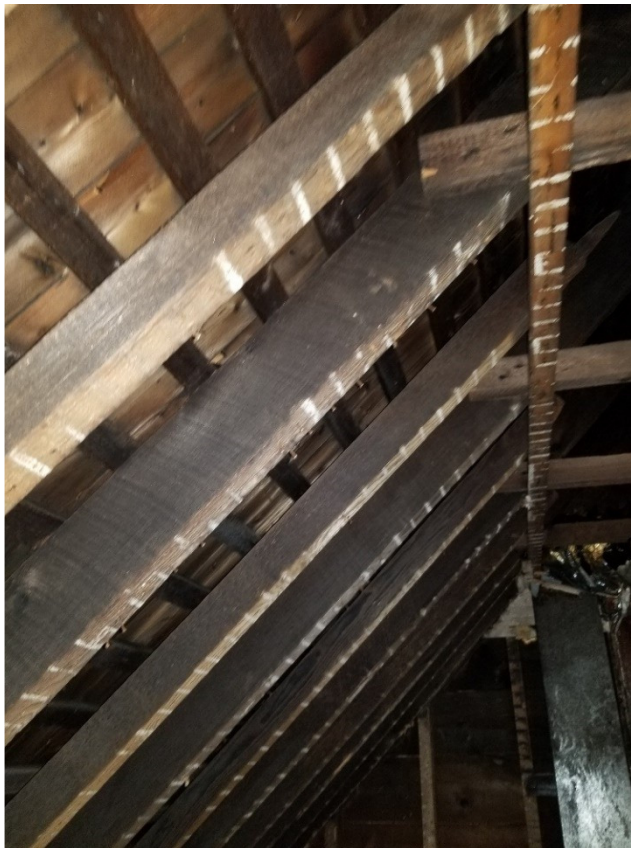
11 and 12. Attic floor –Roof rafters still intact. Roof sheathing charred.

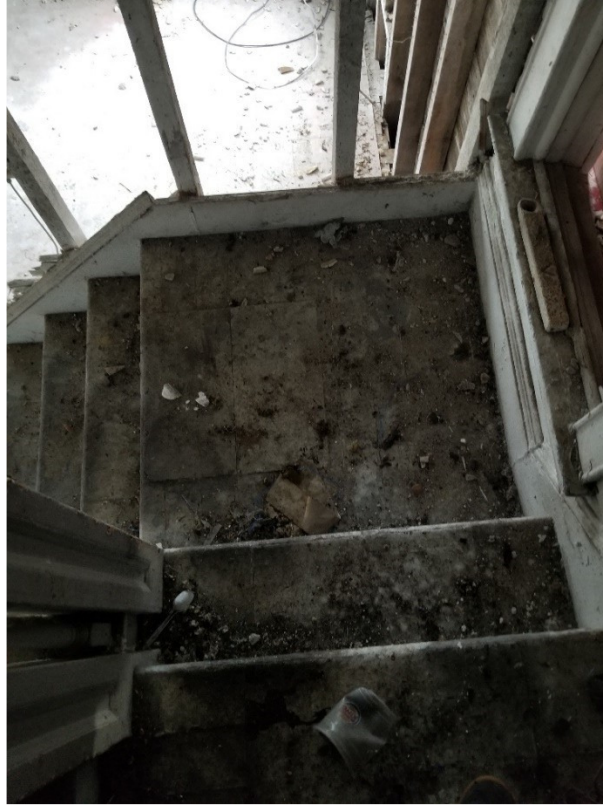
Attic floor mostly still intact except for the holes made by the firefighters to drain water down to cellar. Stairs leading down to the Second floor still on original state and safe. See photos ##13, 16, 17, 20 and 21.

13. Attic floor –Stairs down to Second floor still intact.

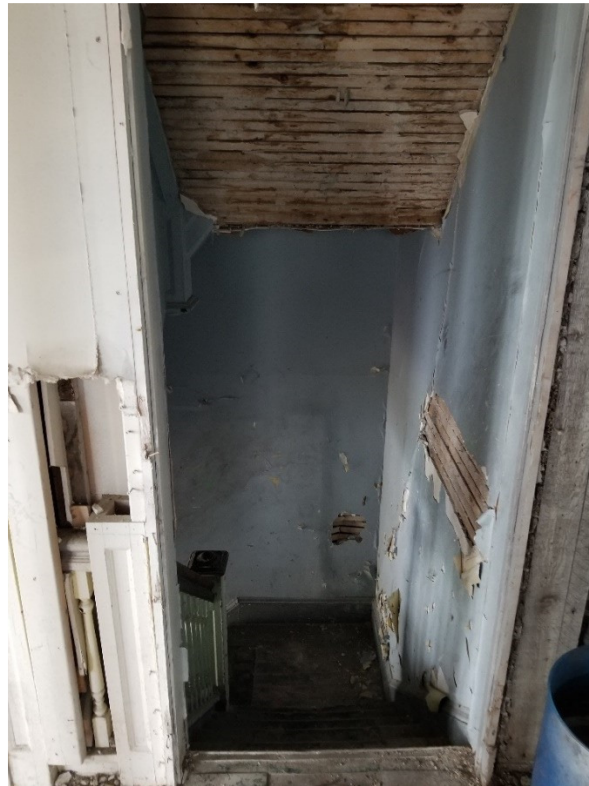
Second floor balloon frame still retain structural stability, safe and sound. Interior partition still in place, untouched by fire, as well as 2"x 8" ceiling joists and most of the floor sheathing. Majority of the windows and frames still untouched by fire. Front and rear Stairs leading down to the First floor still on original state and safe. See photos ##14, 16, 17, 18, 19, 20 and 21.

14. Second floor –Stairs down to First floor still intact.

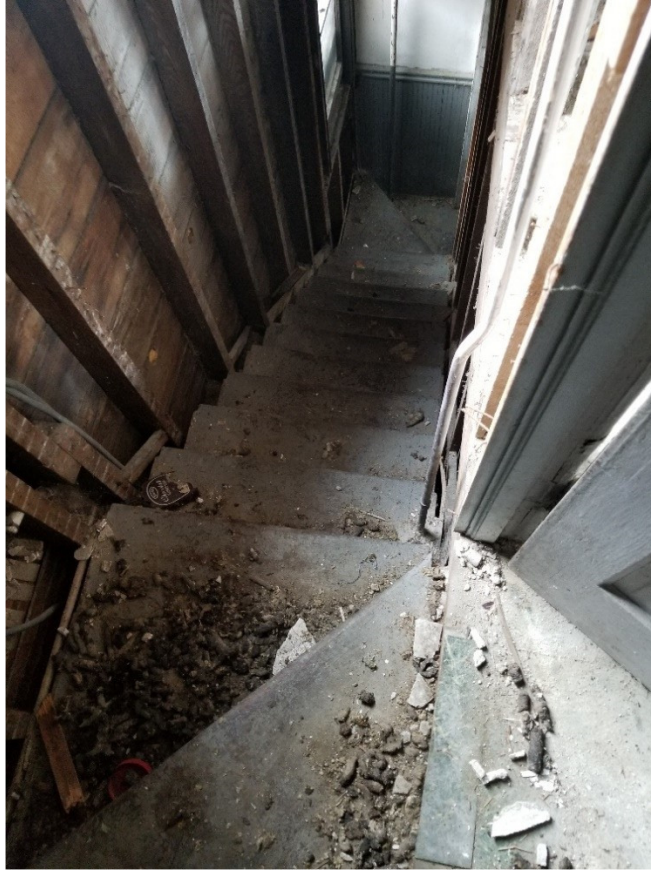
15. Second floor –Rear stairs down to First floor still intact.

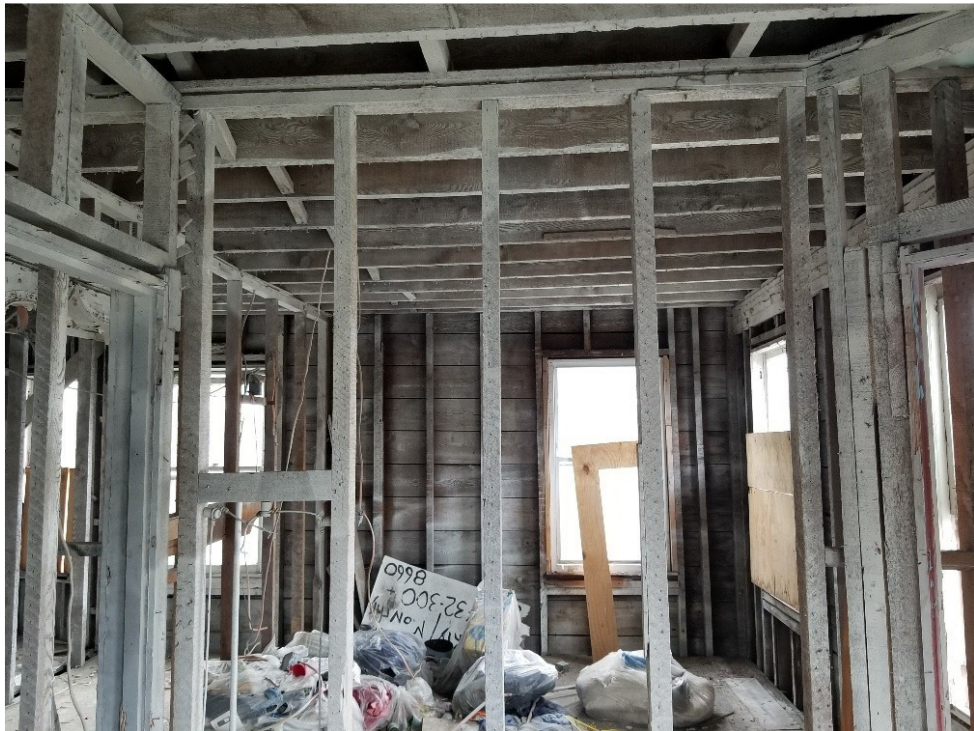
16. Second floor –Interior and exterior framing still intact.

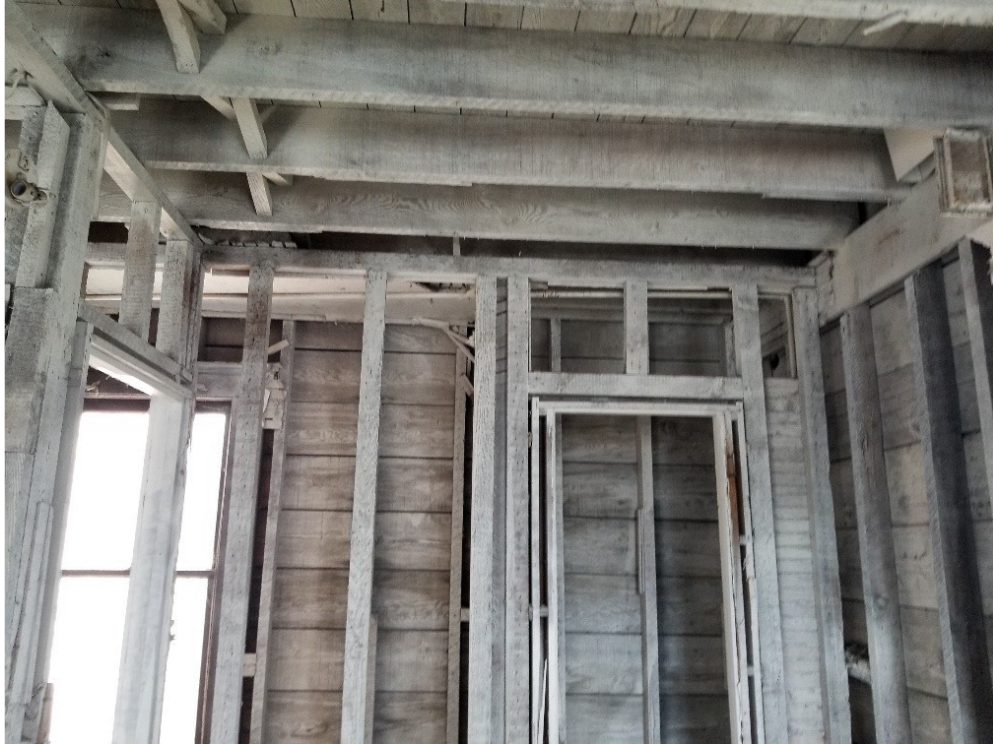
17. Second floor –Ceiling joists, Interior and exterior framing still intact.

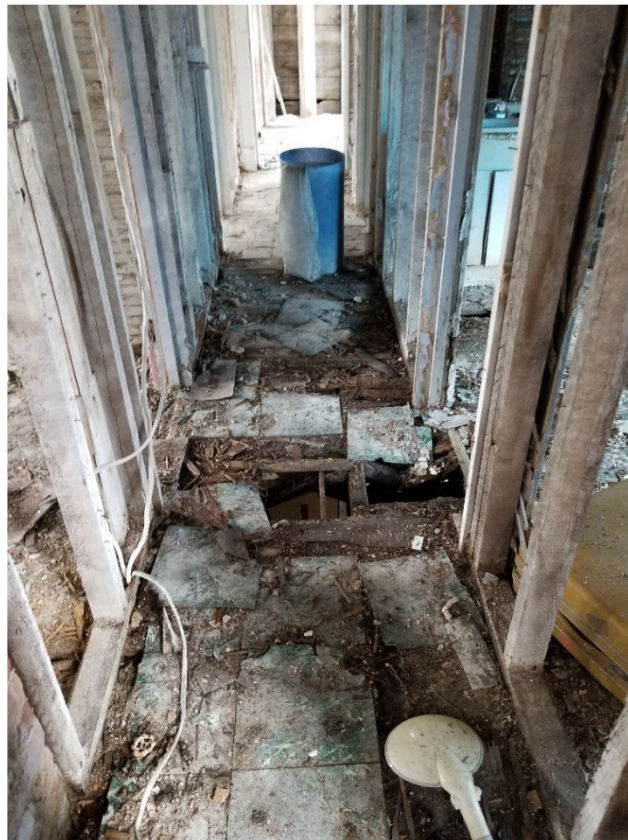
18. Second floor –floor damaged for fighting fire

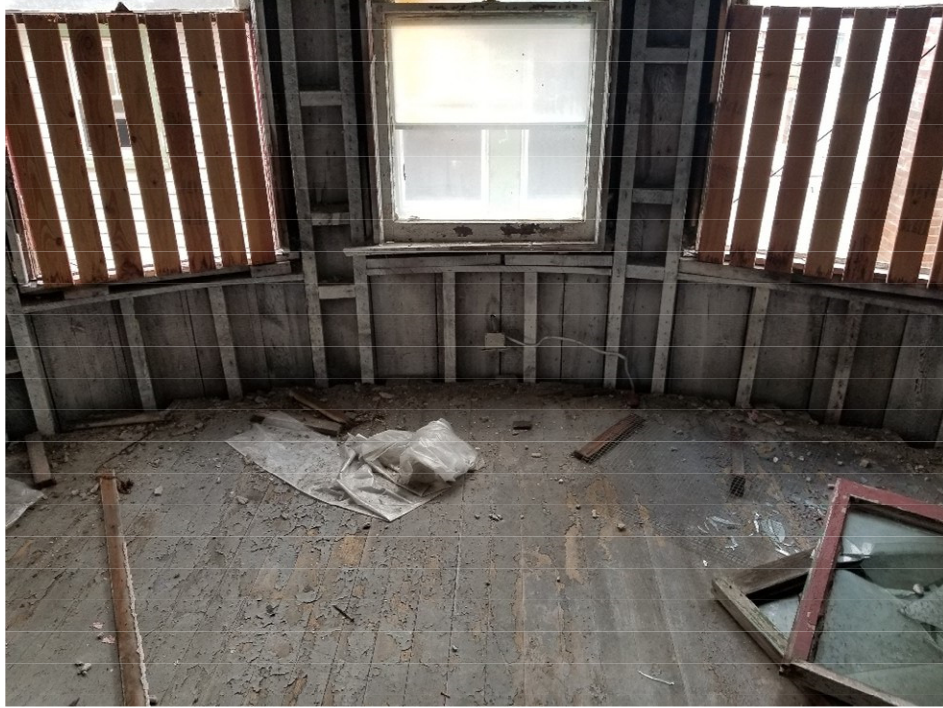
19. Second floor – Exterior framing and floor still intact.

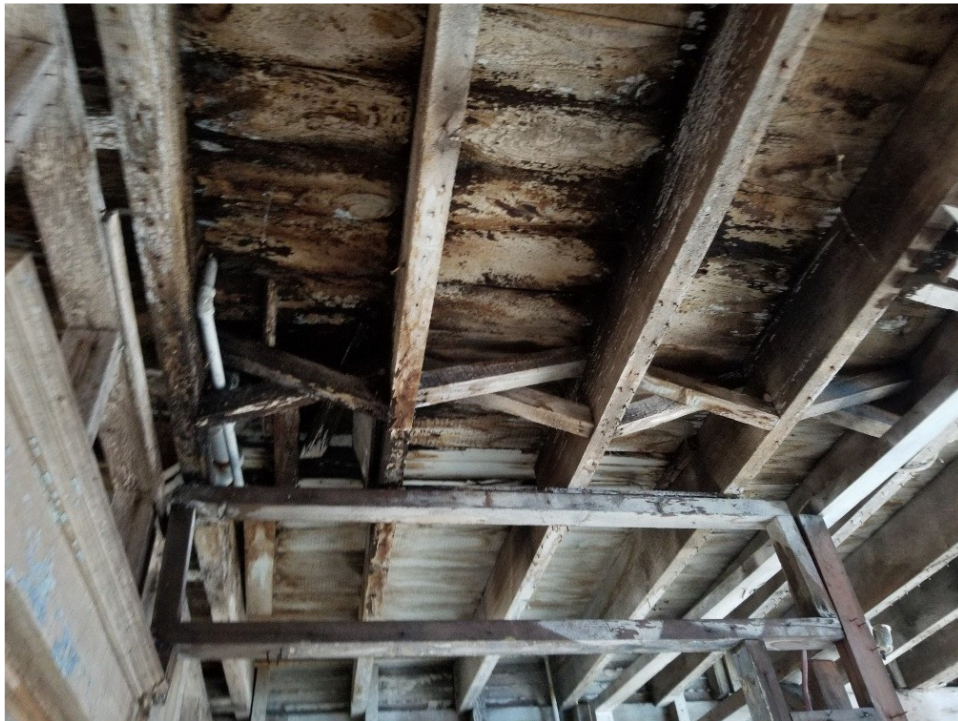
20. Second floor – Ceiling framing still intact.

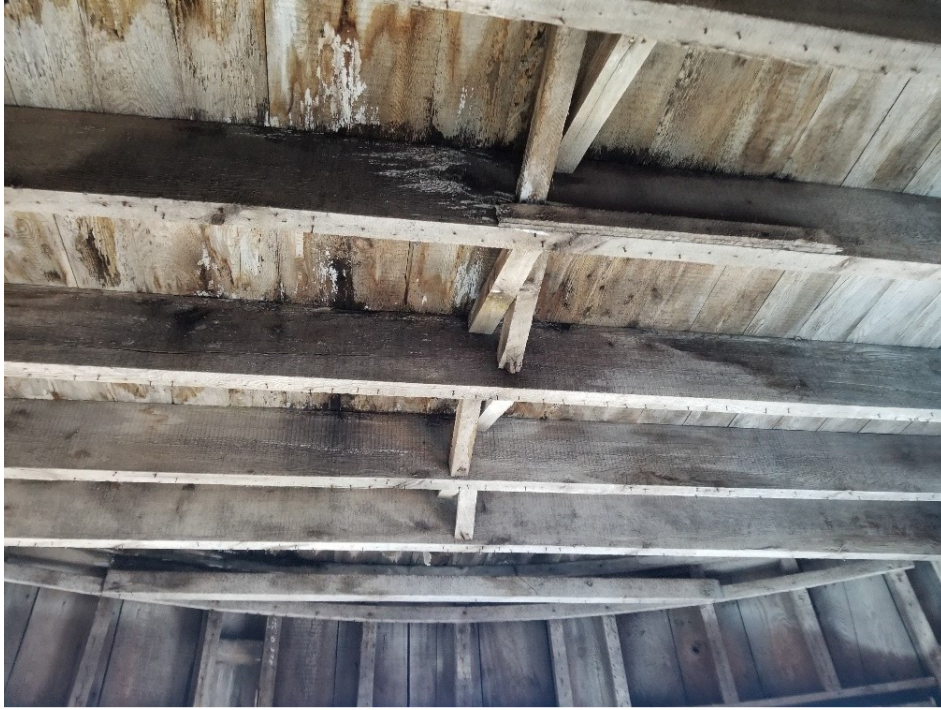
21. Second floor –Ceiling framing still intact.

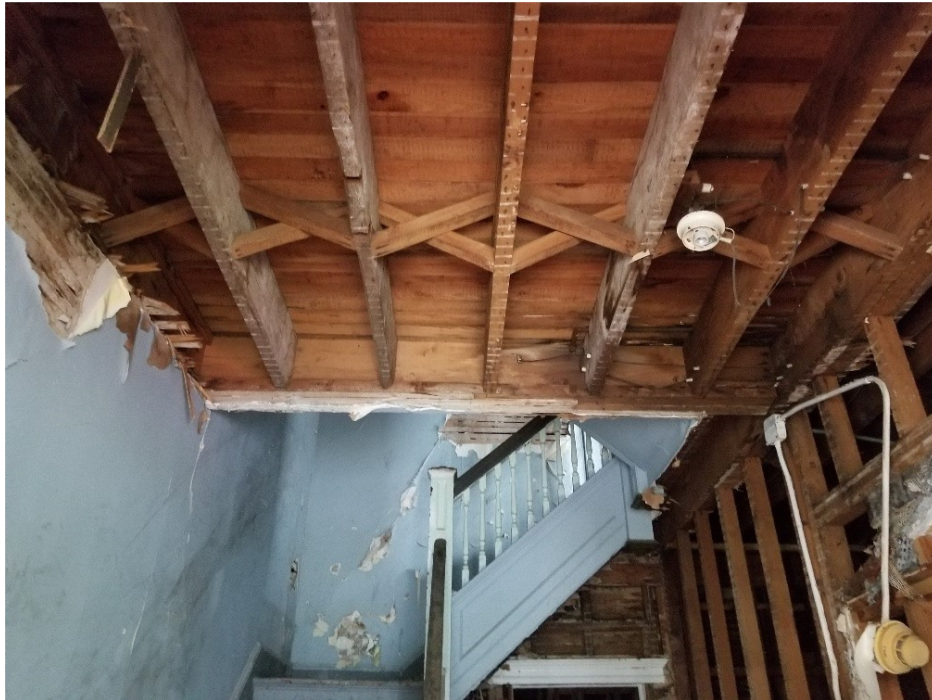
First floor balloon frame still retains structural stability, safe and sound. Interior partition still in place, untouched by fire, as well as 2"x10" ceiling joists and most of the floor sheathing, with an exception to fire damage to the kitchen roof and walls at the rear of the building. An estimated area of fire damage about 5% of the First floor. Some wall studs in vicinity of the kitchen charred by smoke but still retain physical properties. Majority of the windows and frames still untouched by fire. Stairs leading down to the Cellar still on original state and safe. See photos ##22, 23, 24 and 25.

22. First floor –Stairs from the Second floor and ceiling framing still intact.

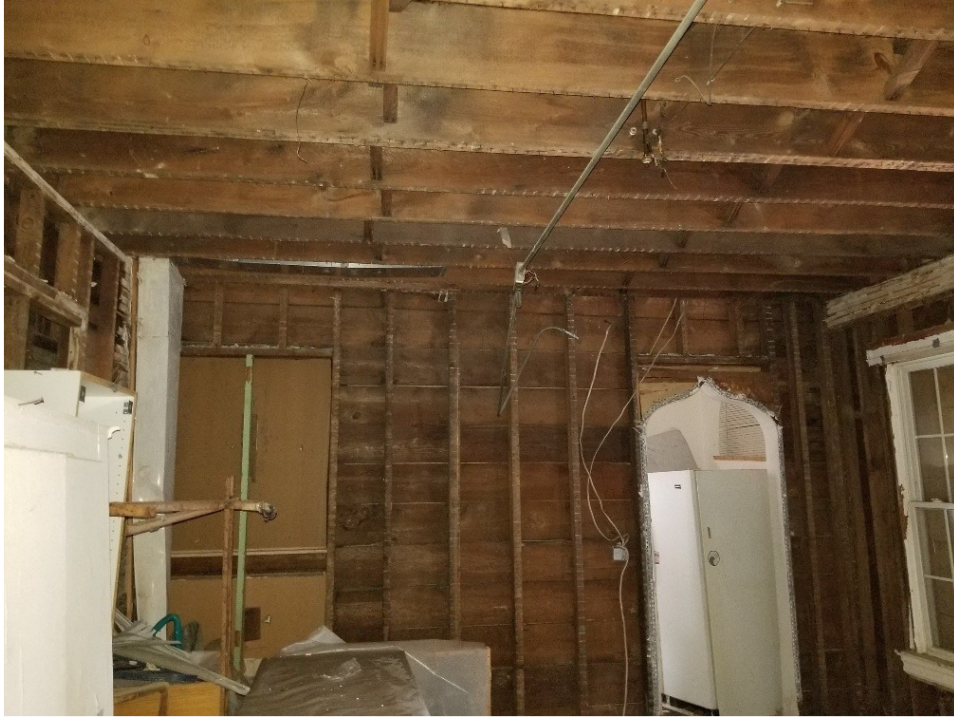
23. First floor –Portions, walls and ceiling framing still intact.

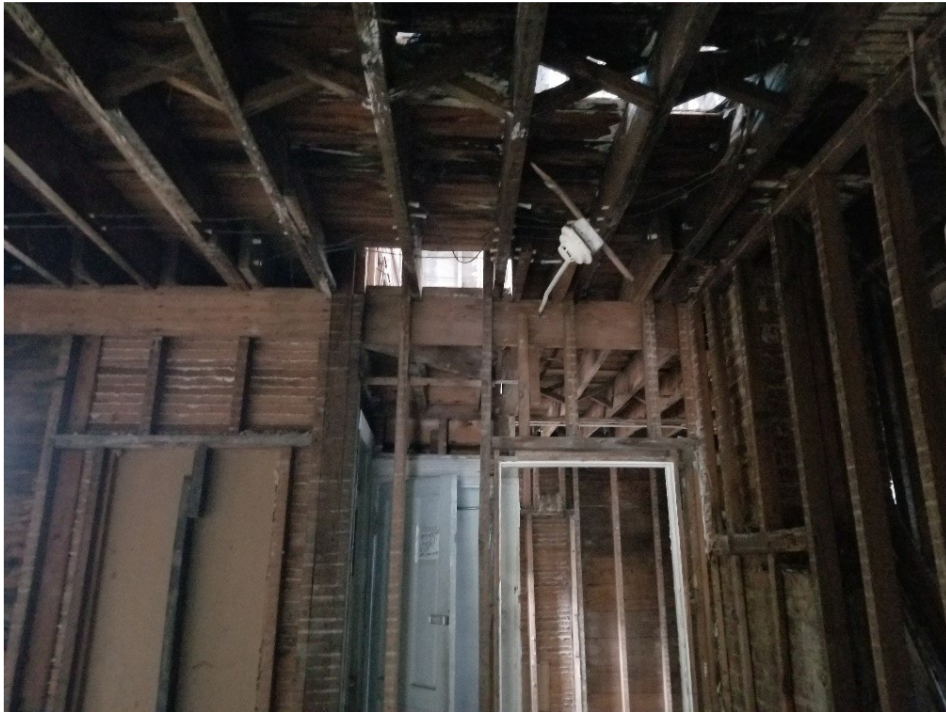
24. First floor –Portions, walls and ceiling framing still intact.

Hole in ceiling by firefighting activities

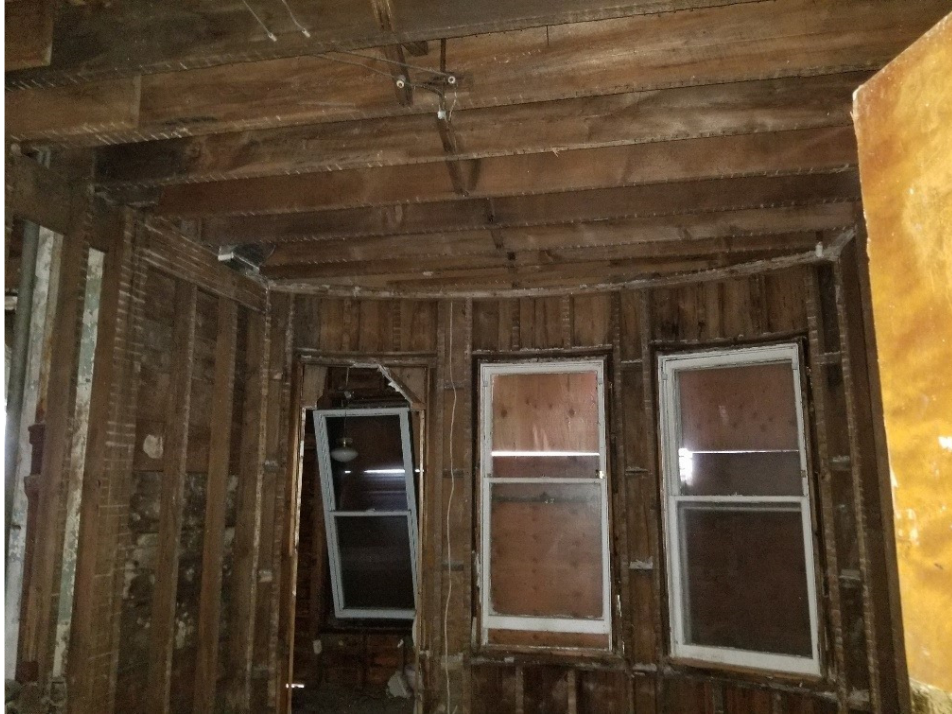
25. First floor –Portions, walls and ceiling framing still intact.

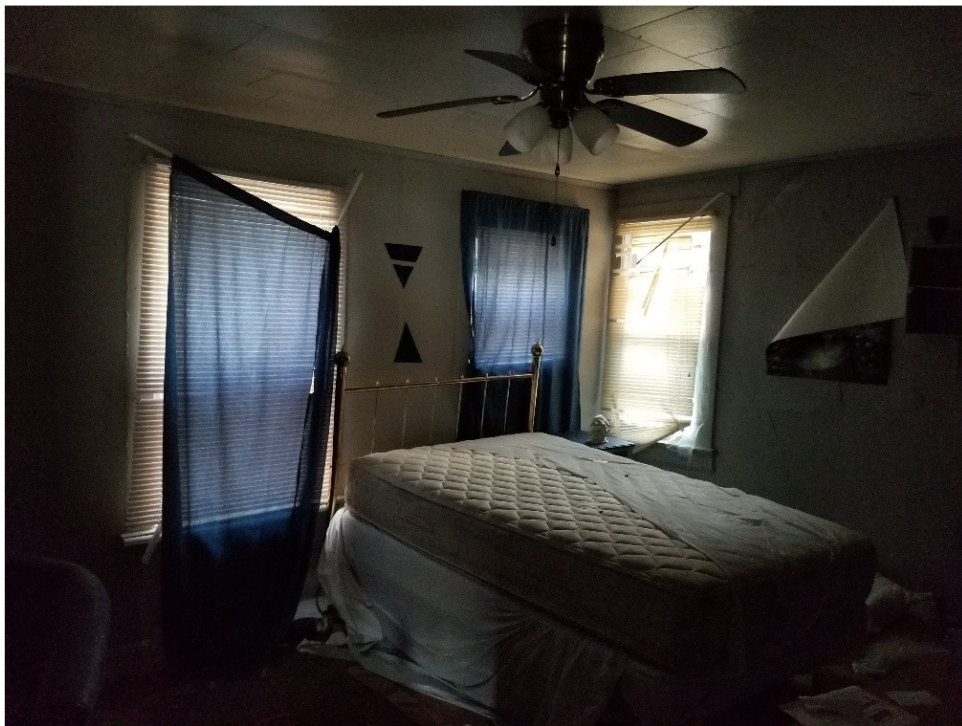
26. First floor –Some rooms sustain no damage at all.

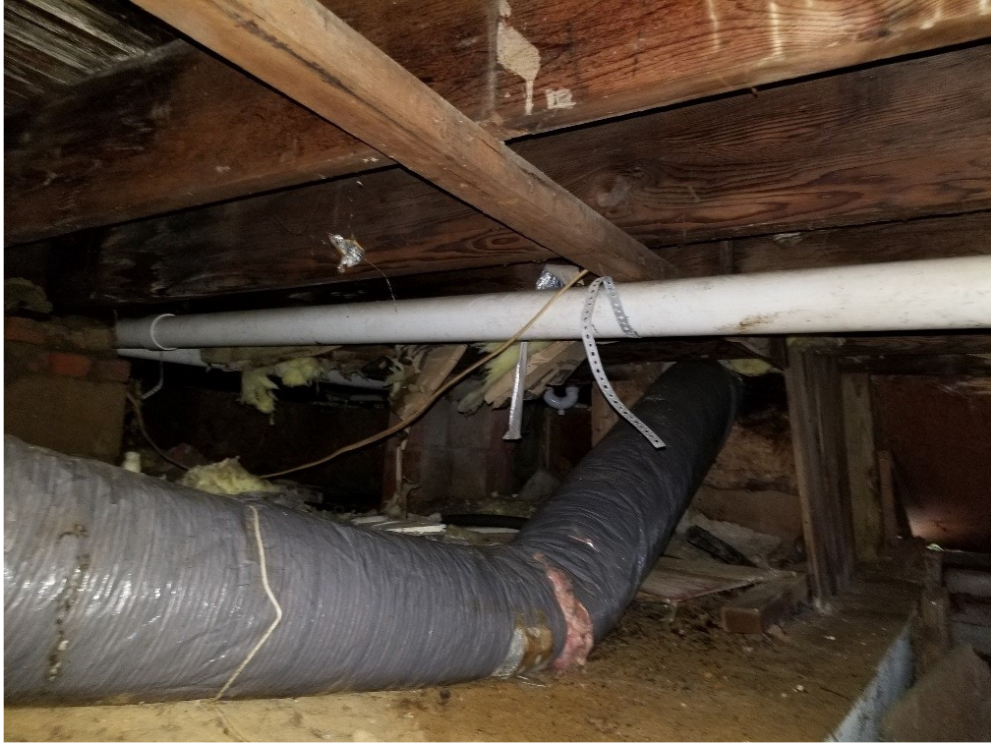
27. Cellar -Crawl space. Floor framing still intact.

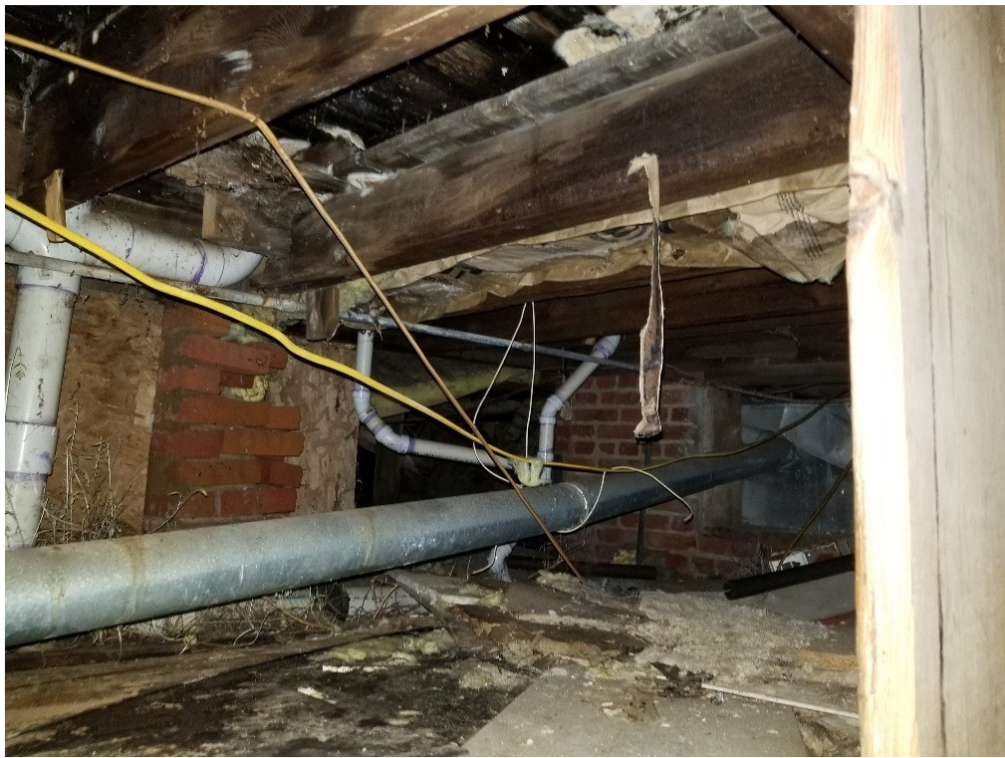
28. Cellar -Crawl space. Floor framing still intact.

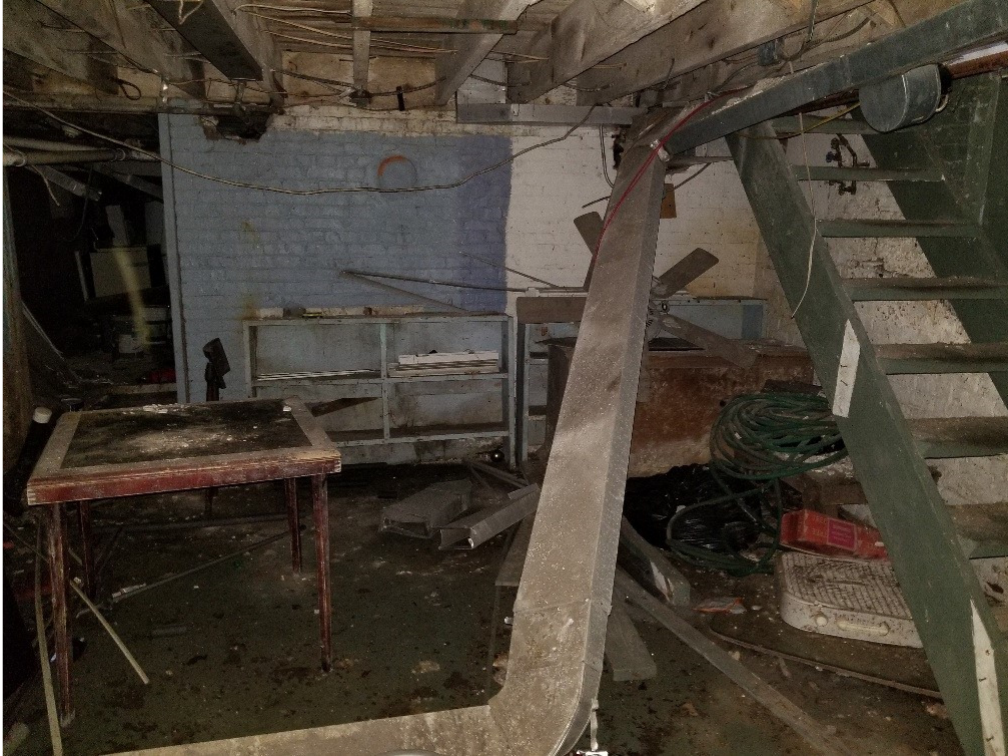
29. Cellar –Foundation walls and Floor framing still intact.

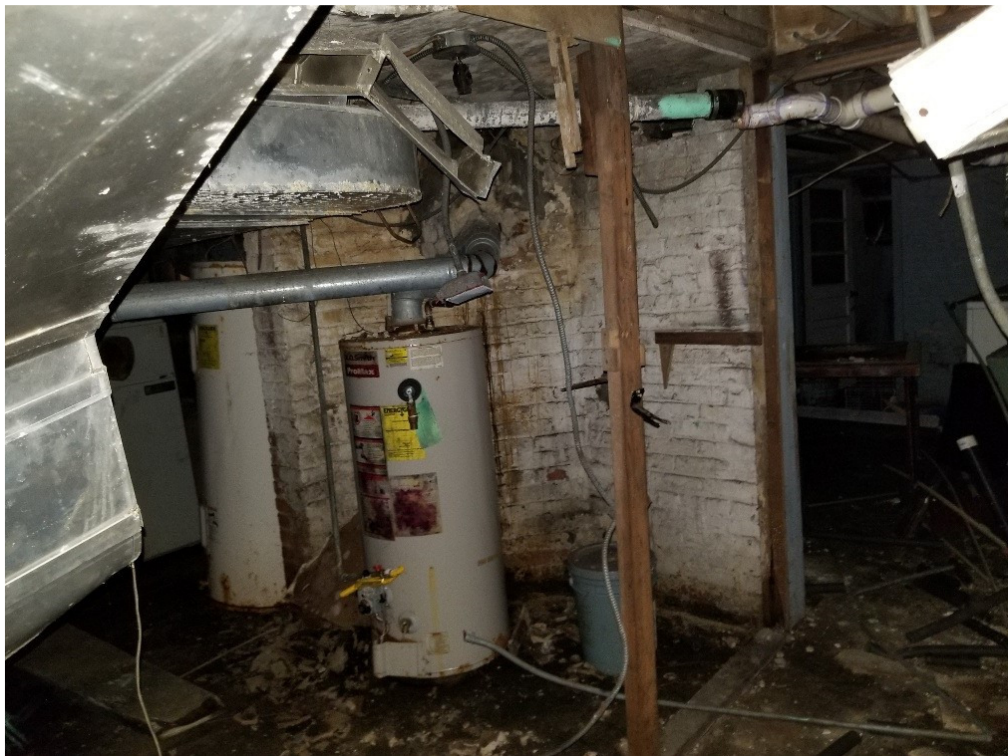
30. Cellar –Foundation walls and Floor framing still intact.

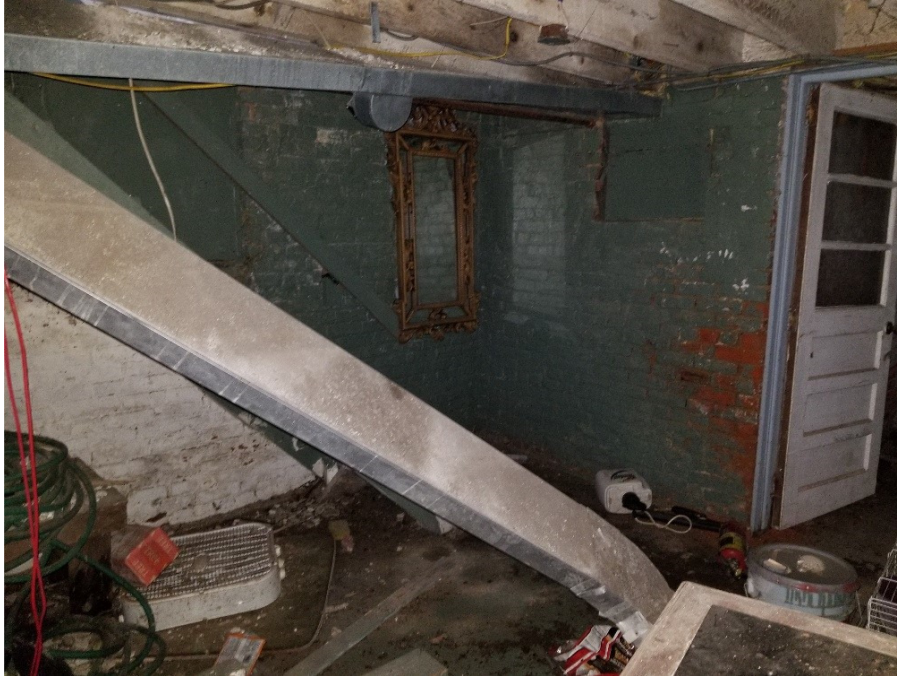
31. Cellar –Foundation walls and Floor framing still intact.
