**FIRST UNITED METHODIST CHURCH
319 LAREINE AVE, BOROUGH OF BRADLEY BEACH, NJ
INITIAL DUE DILIGENCE FACILITY EVALUATION
MECHANICAL, PLUMBING, FIRE PROTECTION AND ELECTRICAL**

October 29, 2021
T&M Project Number BRAD- 00973

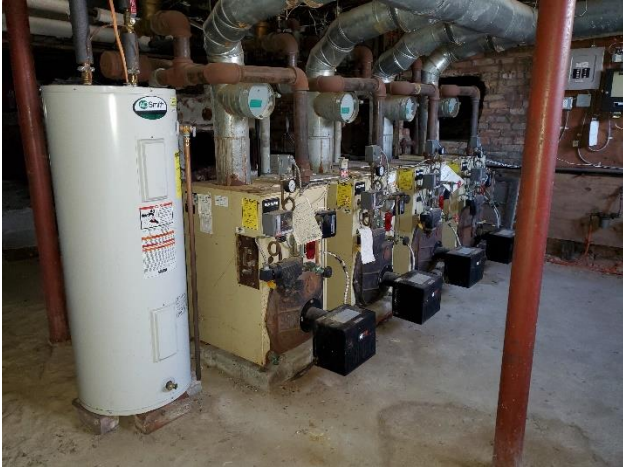
Building heating is provided by four (4) Weil-McLain, oil-fired, steam boilers located in a basement boiler room below the Sanctuary Level nave. These boilers were manufactured in 2004. They are in fair condition however much of the connected steam piping is severely rusted and corroded. The boiler exhaust air is expelled out through a combined flue with a power ventilator at the street level.

Image 1. Front view of boilers in basement boiler room

The boiler and fuel oil system were in fair condition and could be set aside to be reused, which would require inspection before using; however, at 17 years old the boilers and fuel oil system are nearing the end of their median life expectancy. We recommend using a new heating system for any building renovations.

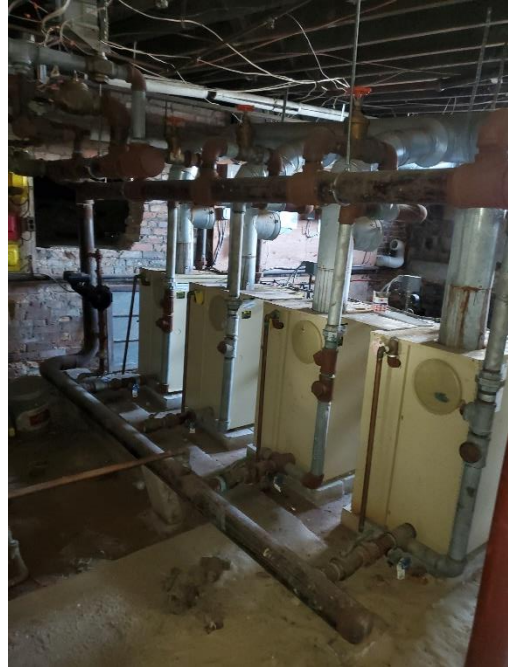
Image 2. Back view of boilers in basement boiler room

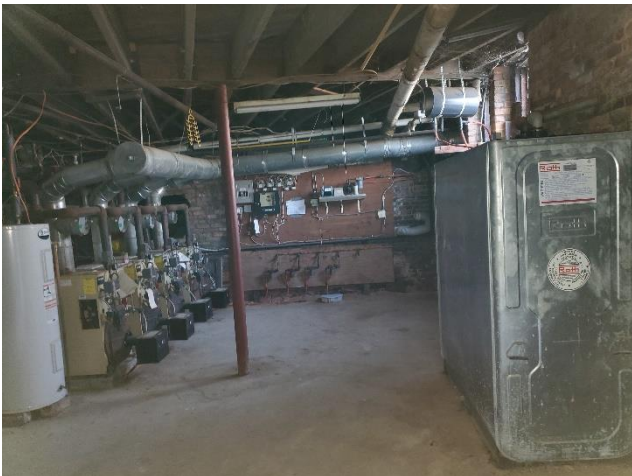
The boilers are supplied with #1 or #2 fuel oil from a 400-gallon tank, pump, and filters within the room. The Roth tank was manufactured in 2004 and is in fair condition. The other parts of the fuel oil system appear to be around the same age and condition.

Image 3. Fuel oil tank, pump, and filter system in the basement boiler room

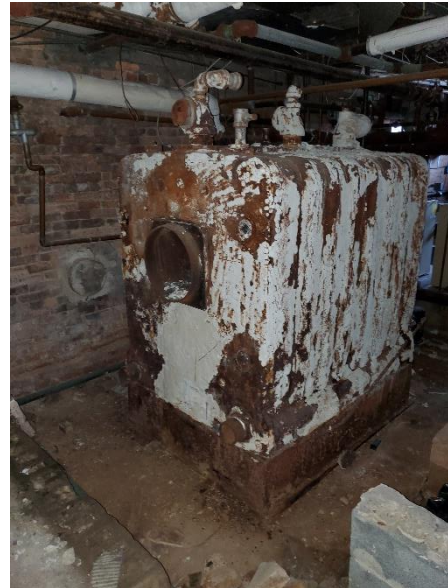
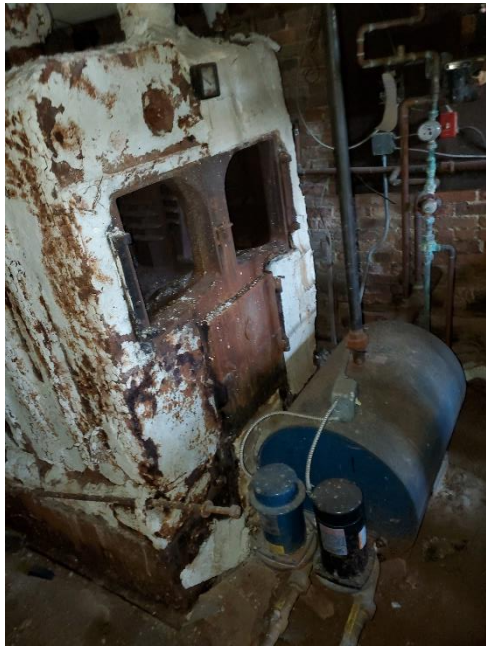
The steam condensate tank and pumps are disconnected from the system and are in complete disrepair.

Image 4. Steam Condensate System in the basement boiler room

Image 5. Steam Condensate System in the basement boiler room

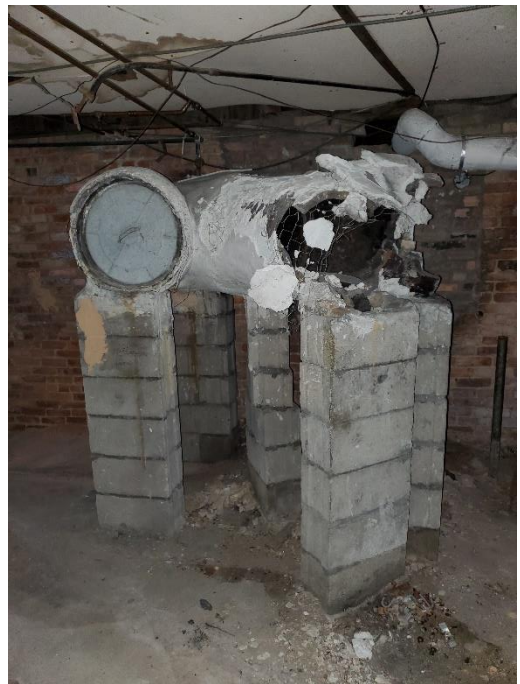
The steam system serves various radiators throughout the building. The radiators appear to be older than the boilers and in fair condition. Steam piping is generally in poor condition with visible rust and severe insulation tearing.

Image 6. Boiler Room steam pipe

The steam piping would require ultrasonic pipe thickness testing, destructive sample testing, or a combination of these test methods to determine if the piping system can be reused. Based on our visual inspection of the condition of the pipe exterior, we recommend installing new steam piping for any building renovations.

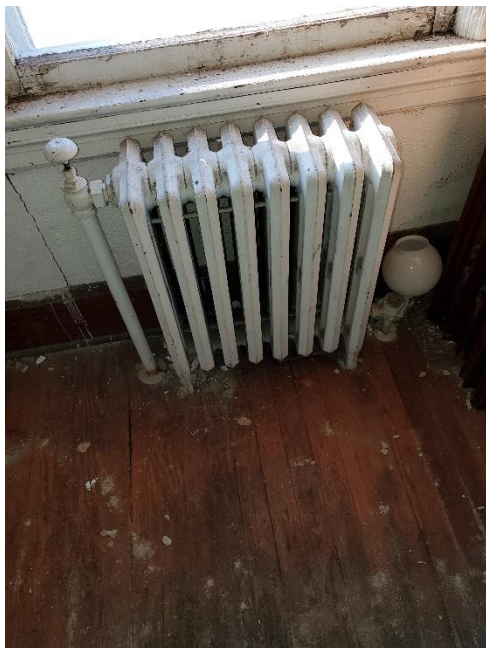
Image 7. Typical Building Steam Radiator

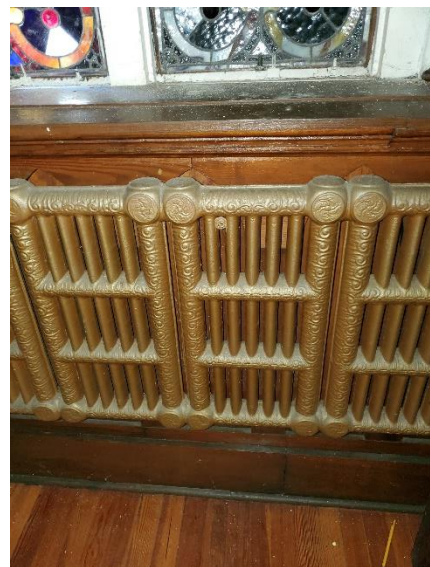
Image 8. Typical Sanctuary Decorative Radiator

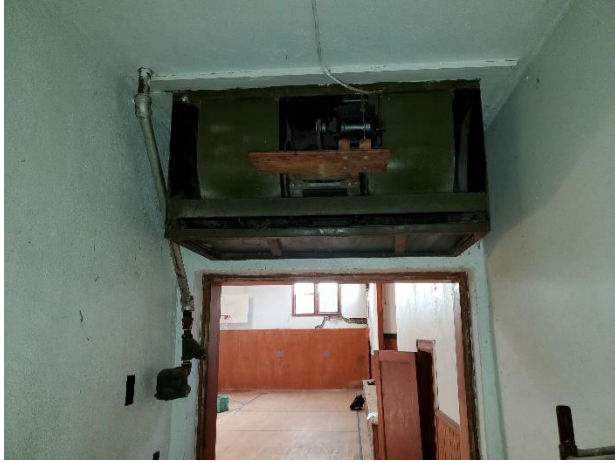
The gym is served by two (2) steam fan-coil units in the Madison Ave stairwell and steam radiators in the entrances. All gym equipment is in poor condition.

Image 9. Gymnasium fan coil blower

The gym HVAC systems should not be reused for renovations. Any gym renovations should be provided with new systems.

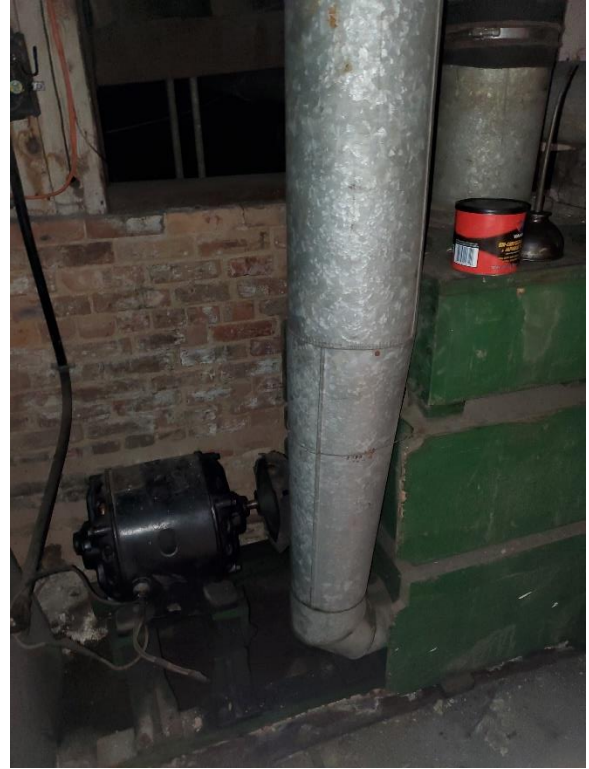
There is a blower unit below the organ that we assume serves the organ.

Image 10. Blower unit below the organ
