PHASE II SUBSURFACE INVESTIGATION REPORT

Repair Shop
811 Main Street
Bradley Beach, New Jersey 07720

November 15, 2018
Partner Project Number: 18-226412.2

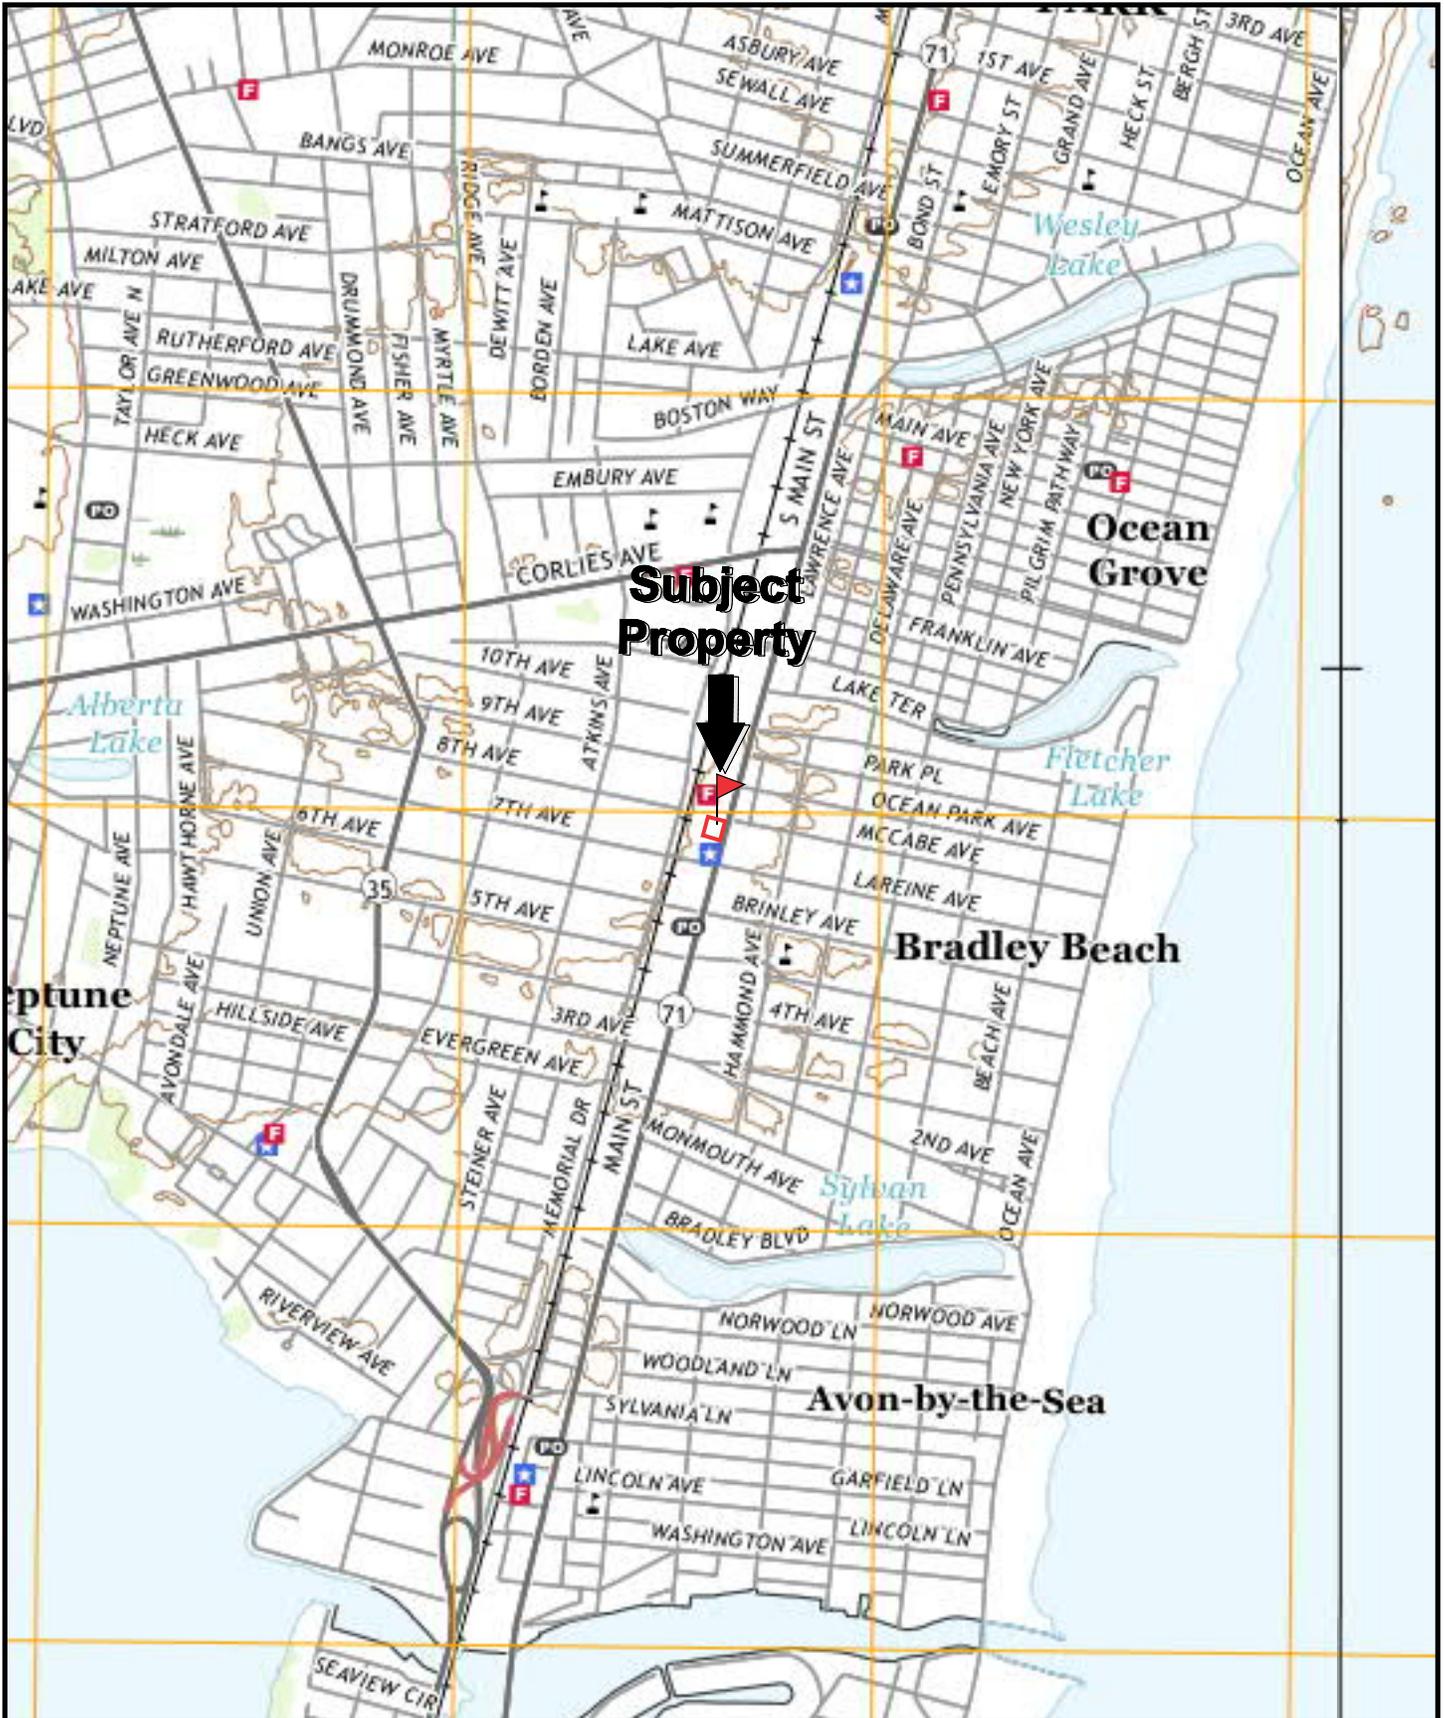
| Figure | Prepared By | Date |
|---|---|---|
| 2 | C. Niedzwiecki | November 2018 |

**Subject
Property**

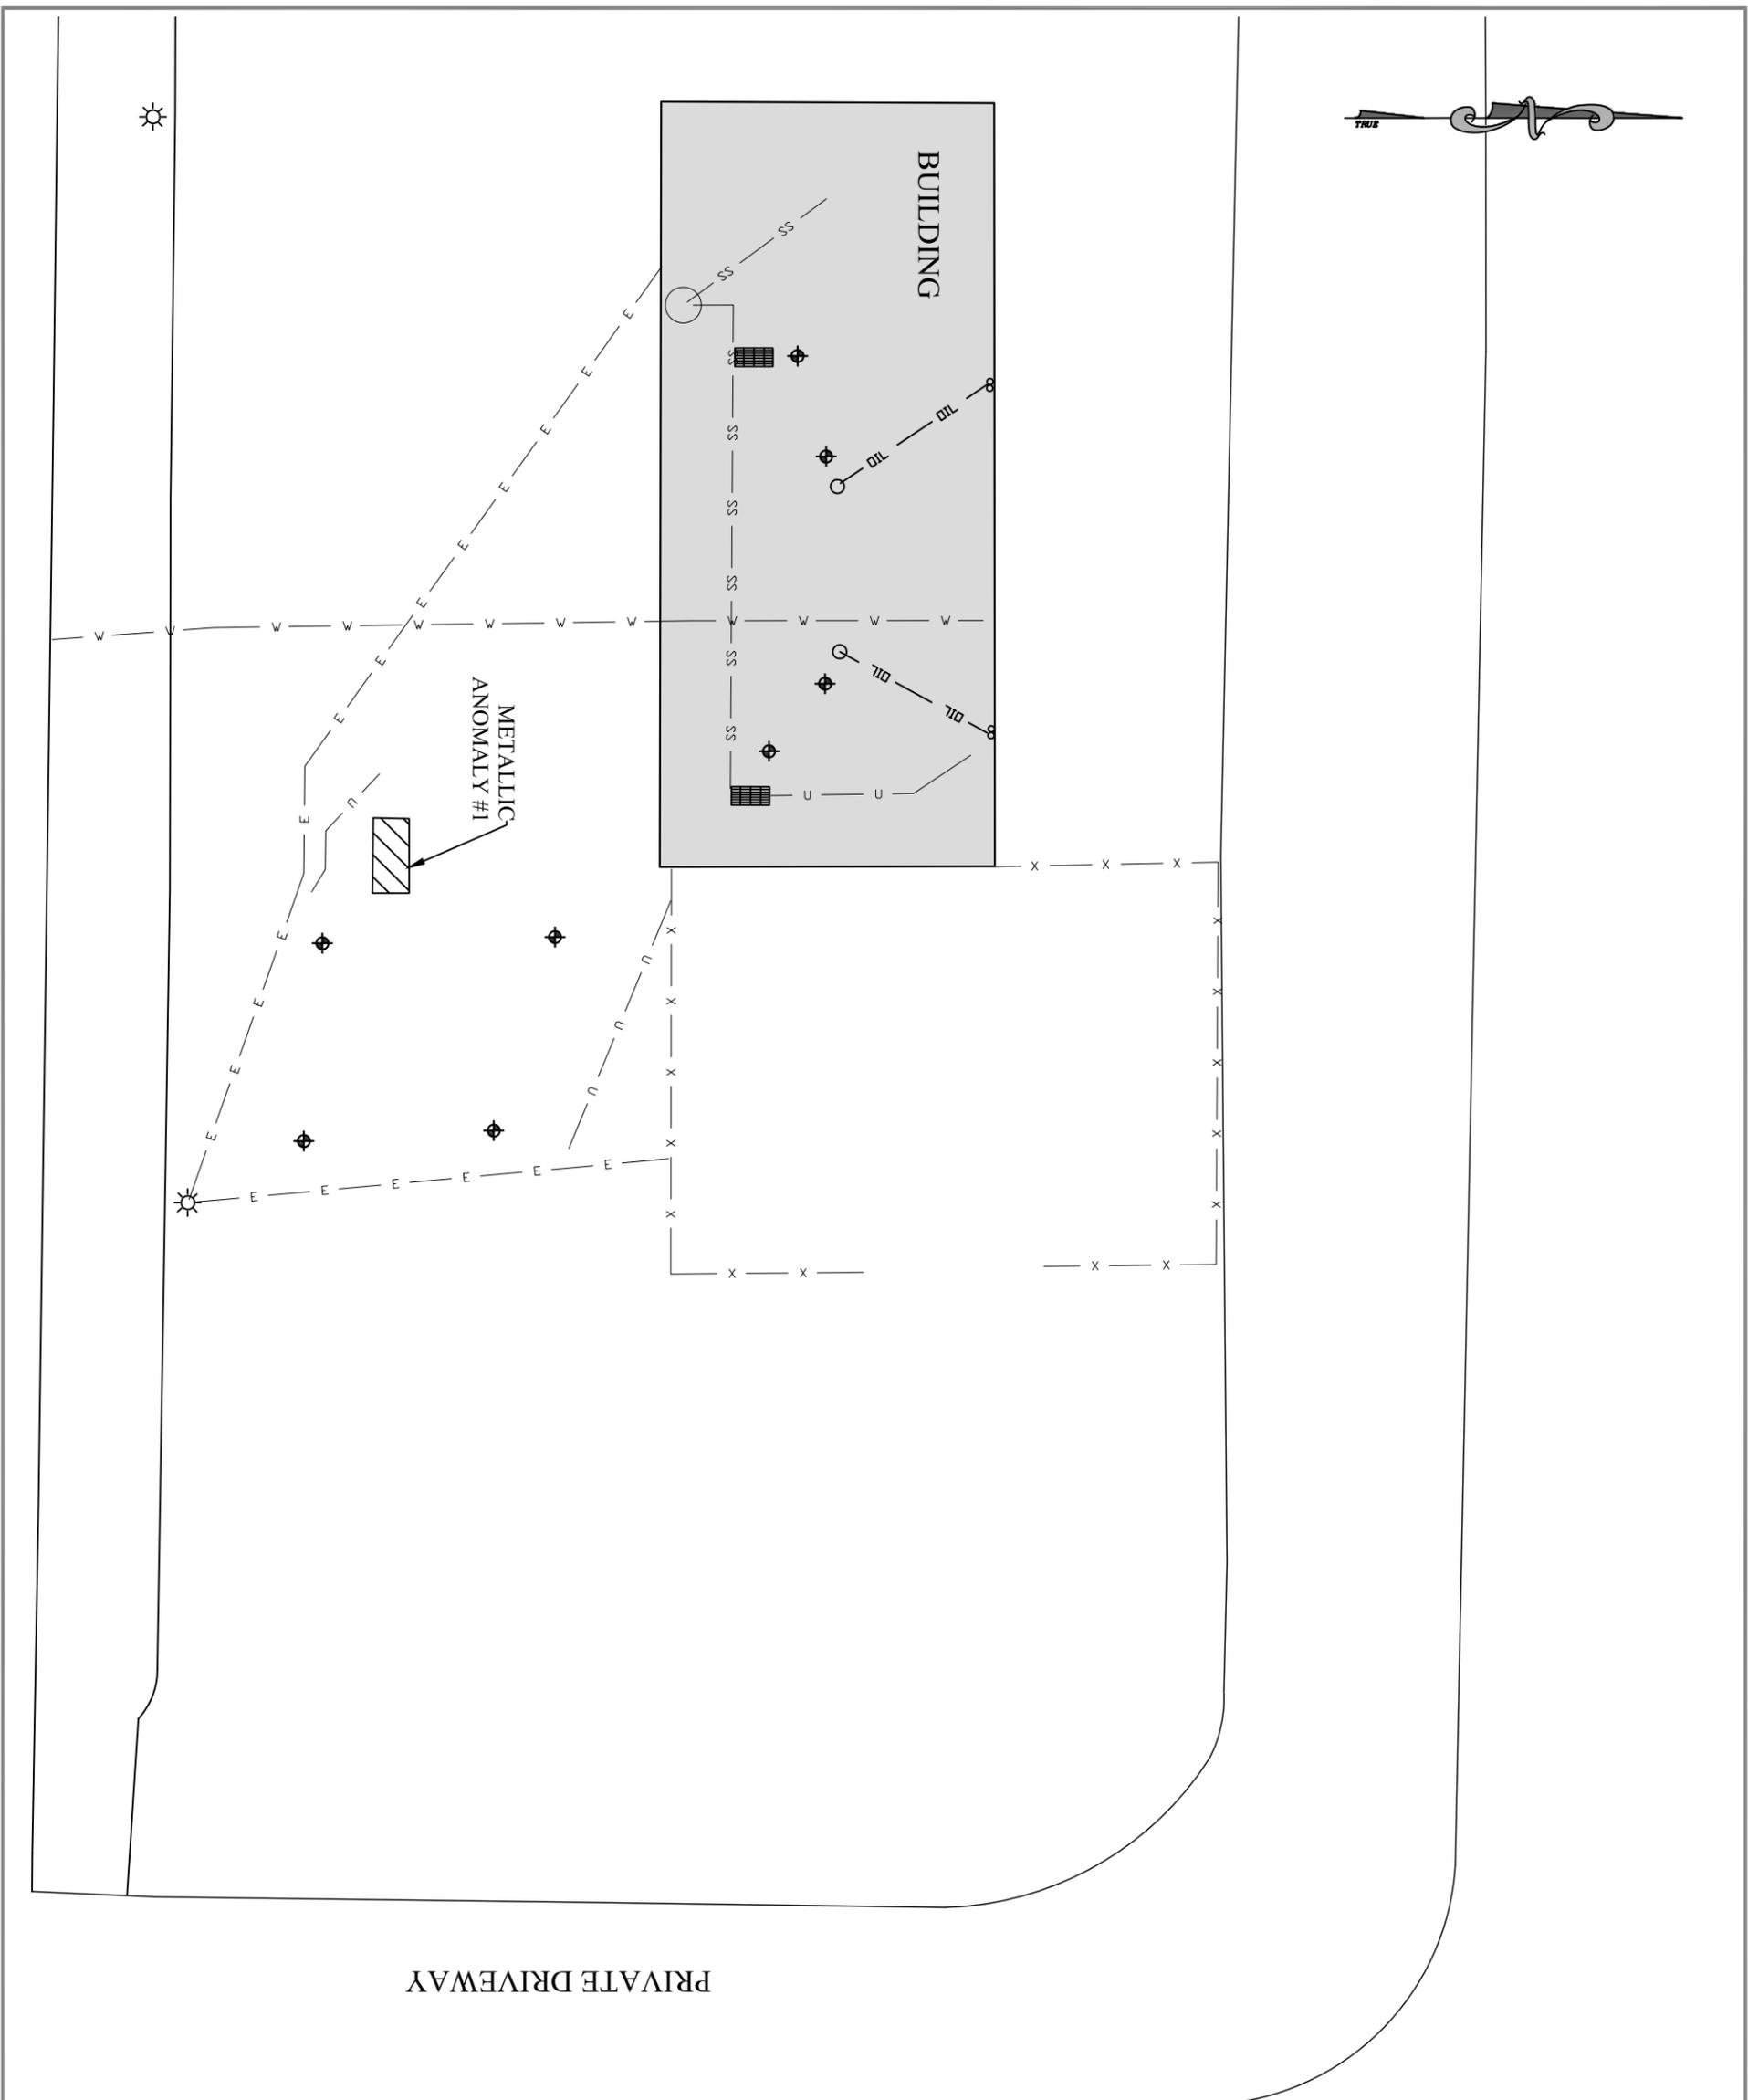
On **October 31, 2018** Delta Geophysics personnel performed a limited geophysical investigation at **811 Main Street, Bradley Beach, NJ.** The area of interest included south of the main building, and inside the main building. An underground storage tank (UST) was believed to have been removed from the area and its exact location was uncertain. During the time of the survey, subsurface conditions were unknown; surface conditions consisted of asphalt, concrete, and grass.
