STORMWATER MANAGEMENT OPERATIONS AND MAINTENANCE MANUAL

**BLOCK 7, LOT 2.03
501-511 LAKE TERRACE**

**BOROUGH OF BRADLEY BEACH
MONMOUTH COUNTY, NJ**

Insite Job #: 20-1472-01

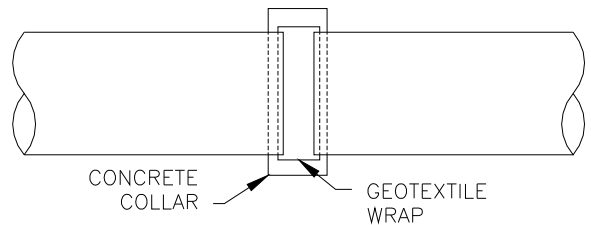
Concrete collars also provide a soil-tight repair, dependent on the integrity of the installation. Installing a concrete collar involves building a form around the area to be repaired and encasing it in concrete. A geotextile is usually wrapped around the repair area prior to pouring the collar to keep the concrete from seeping into the pipe. Typically, approximately 6" (0.15m) is excavated beneath the pipe to allow for proper application of the geotextile and concrete encasement. If the pipe itself is damaged, the damaged area shall be removed and a replacement pipe section spliced in prior to pouring the collar. In order to provide a greater level of joint performance, a gasket can be installed on the pipe in the concrete encasement. Concrete collars are typically more costly and time consuming than snap couplers or split band couplers but are reasonable repair options for soil-tight smooth interior thermoplastic pipe products.

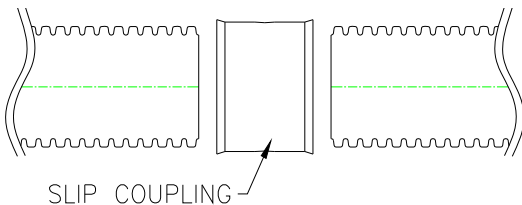
Slip Couplings 12- through 24-inch (300 – 600 mm), provides a watertight repair that will meet most pressure testing requirements, when installed correctly. The slip coupling uses PVC bells with gaskets. The gaskets are placed in the valleys on either side of the section to be repaired and slip couplings are then slid over the gaskets. Due to the exterior gasket, the slip coupling can only be used on pipe with a corrugated exterior. PVC slip couplings are most commonly used with watertight smooth interior, corrugated exterior thermoplastic pipe products.

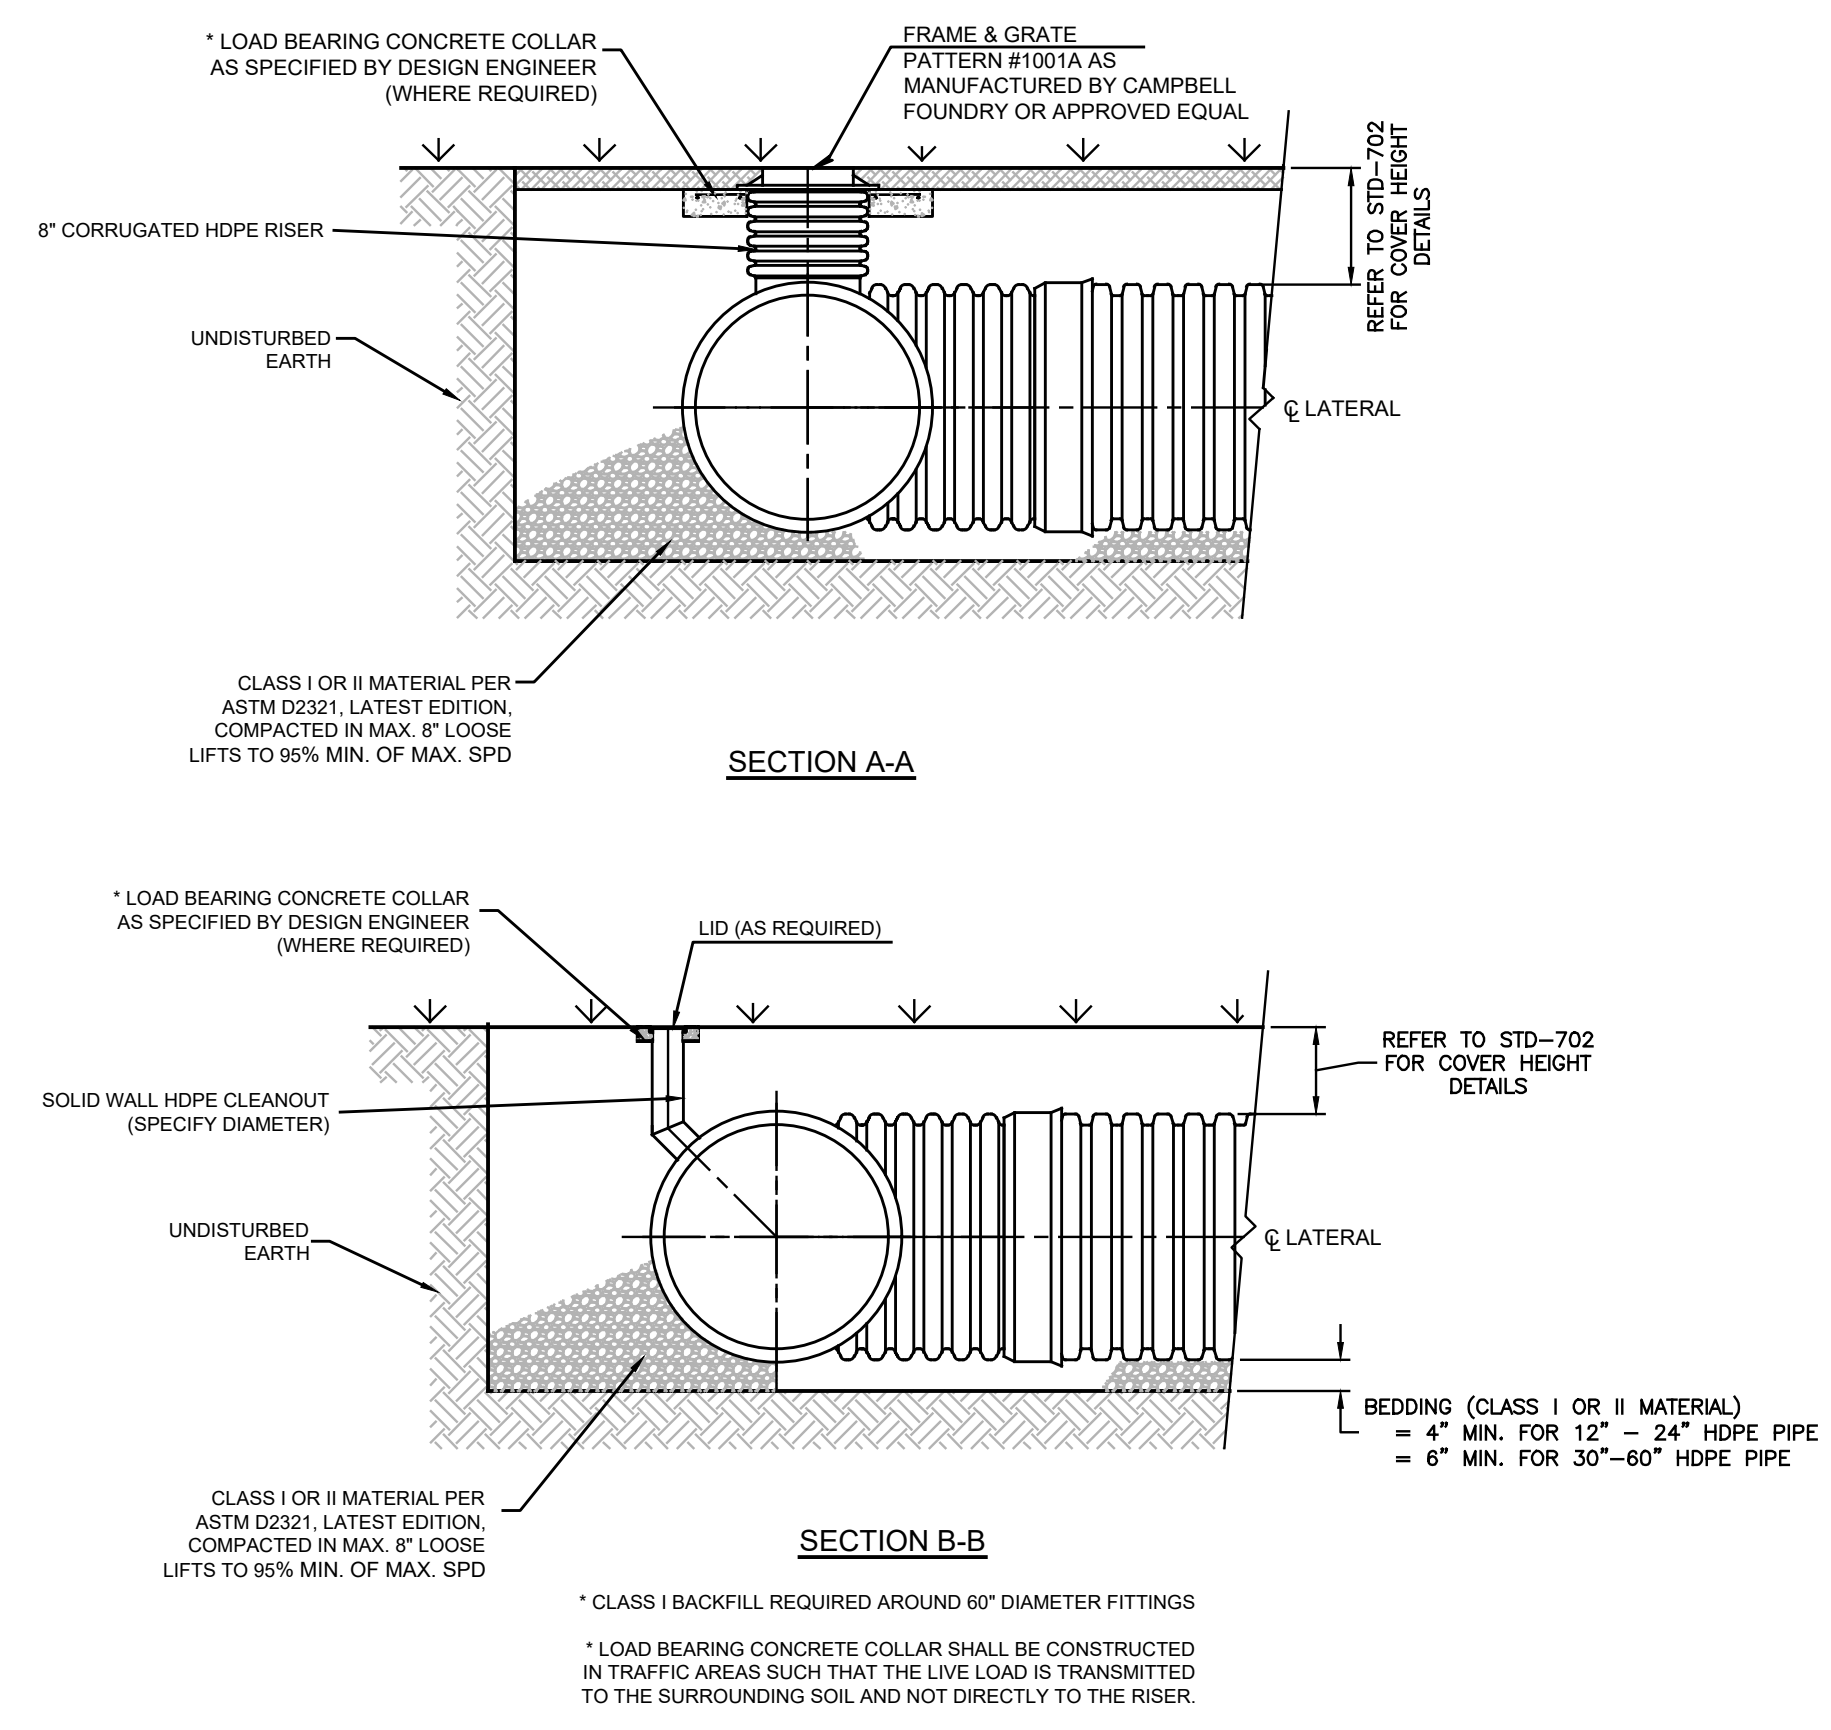
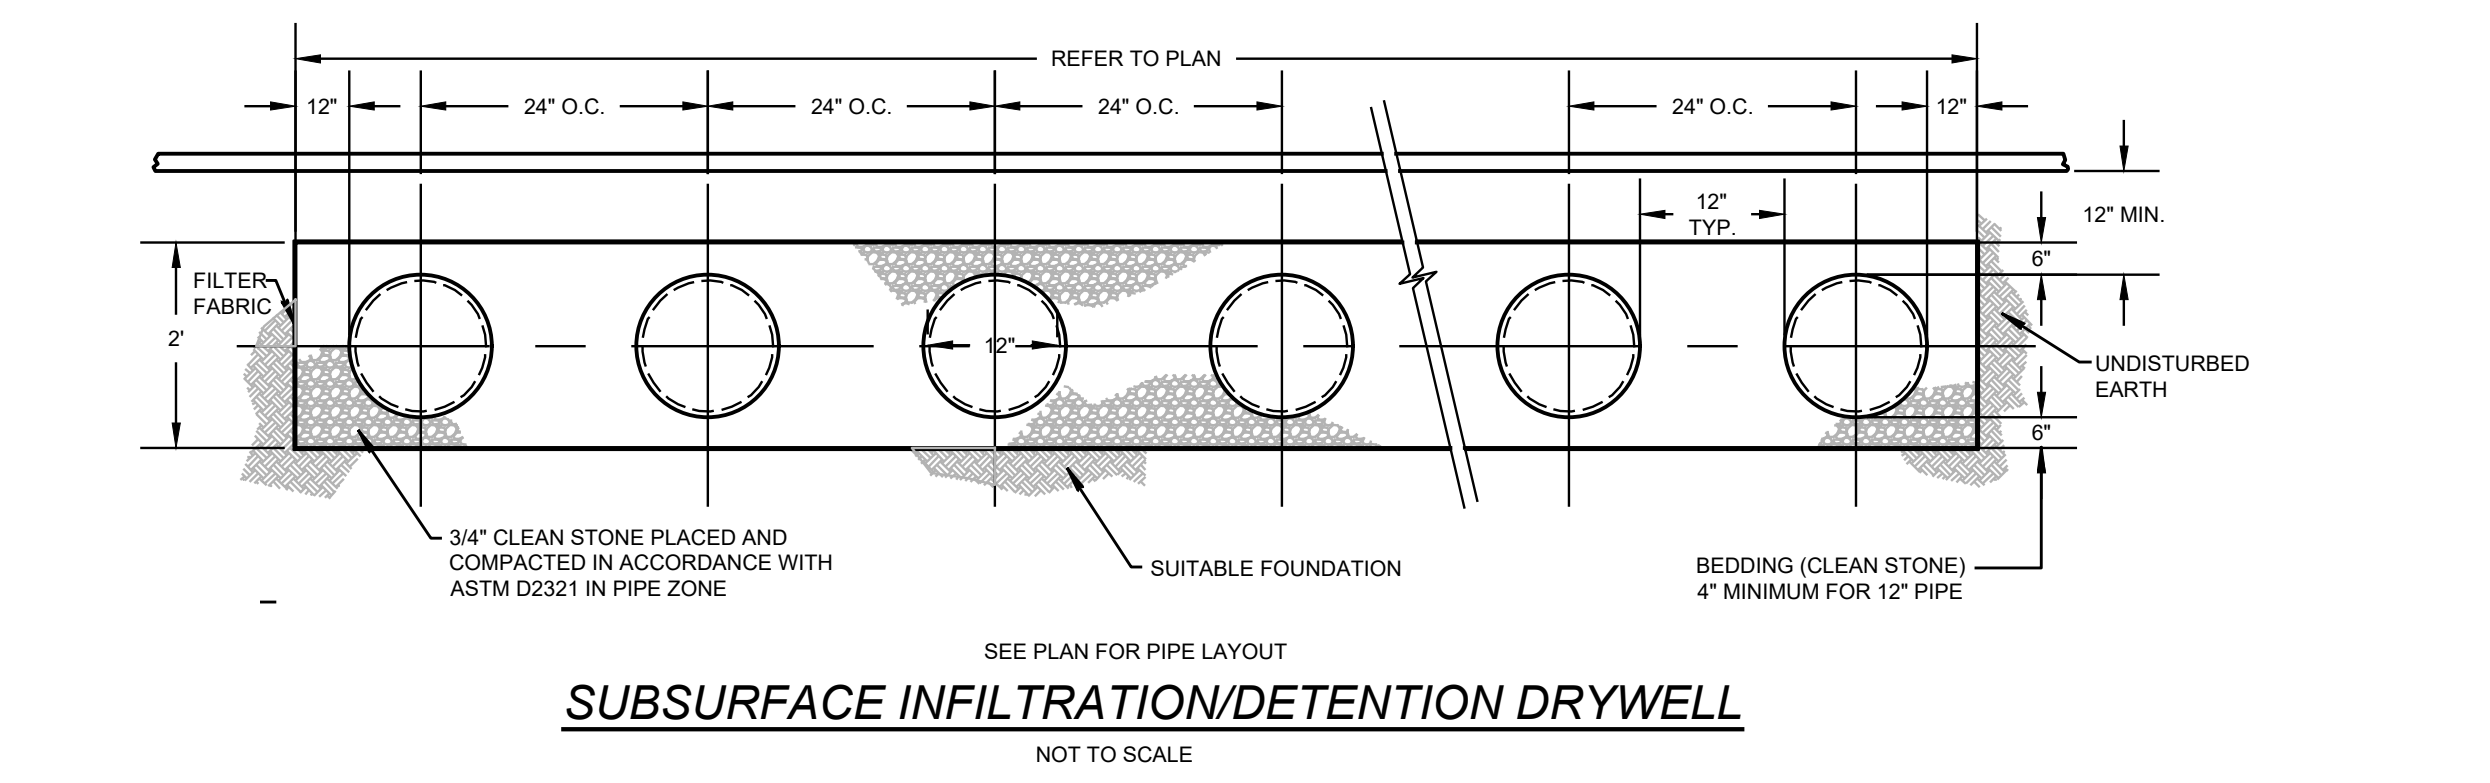
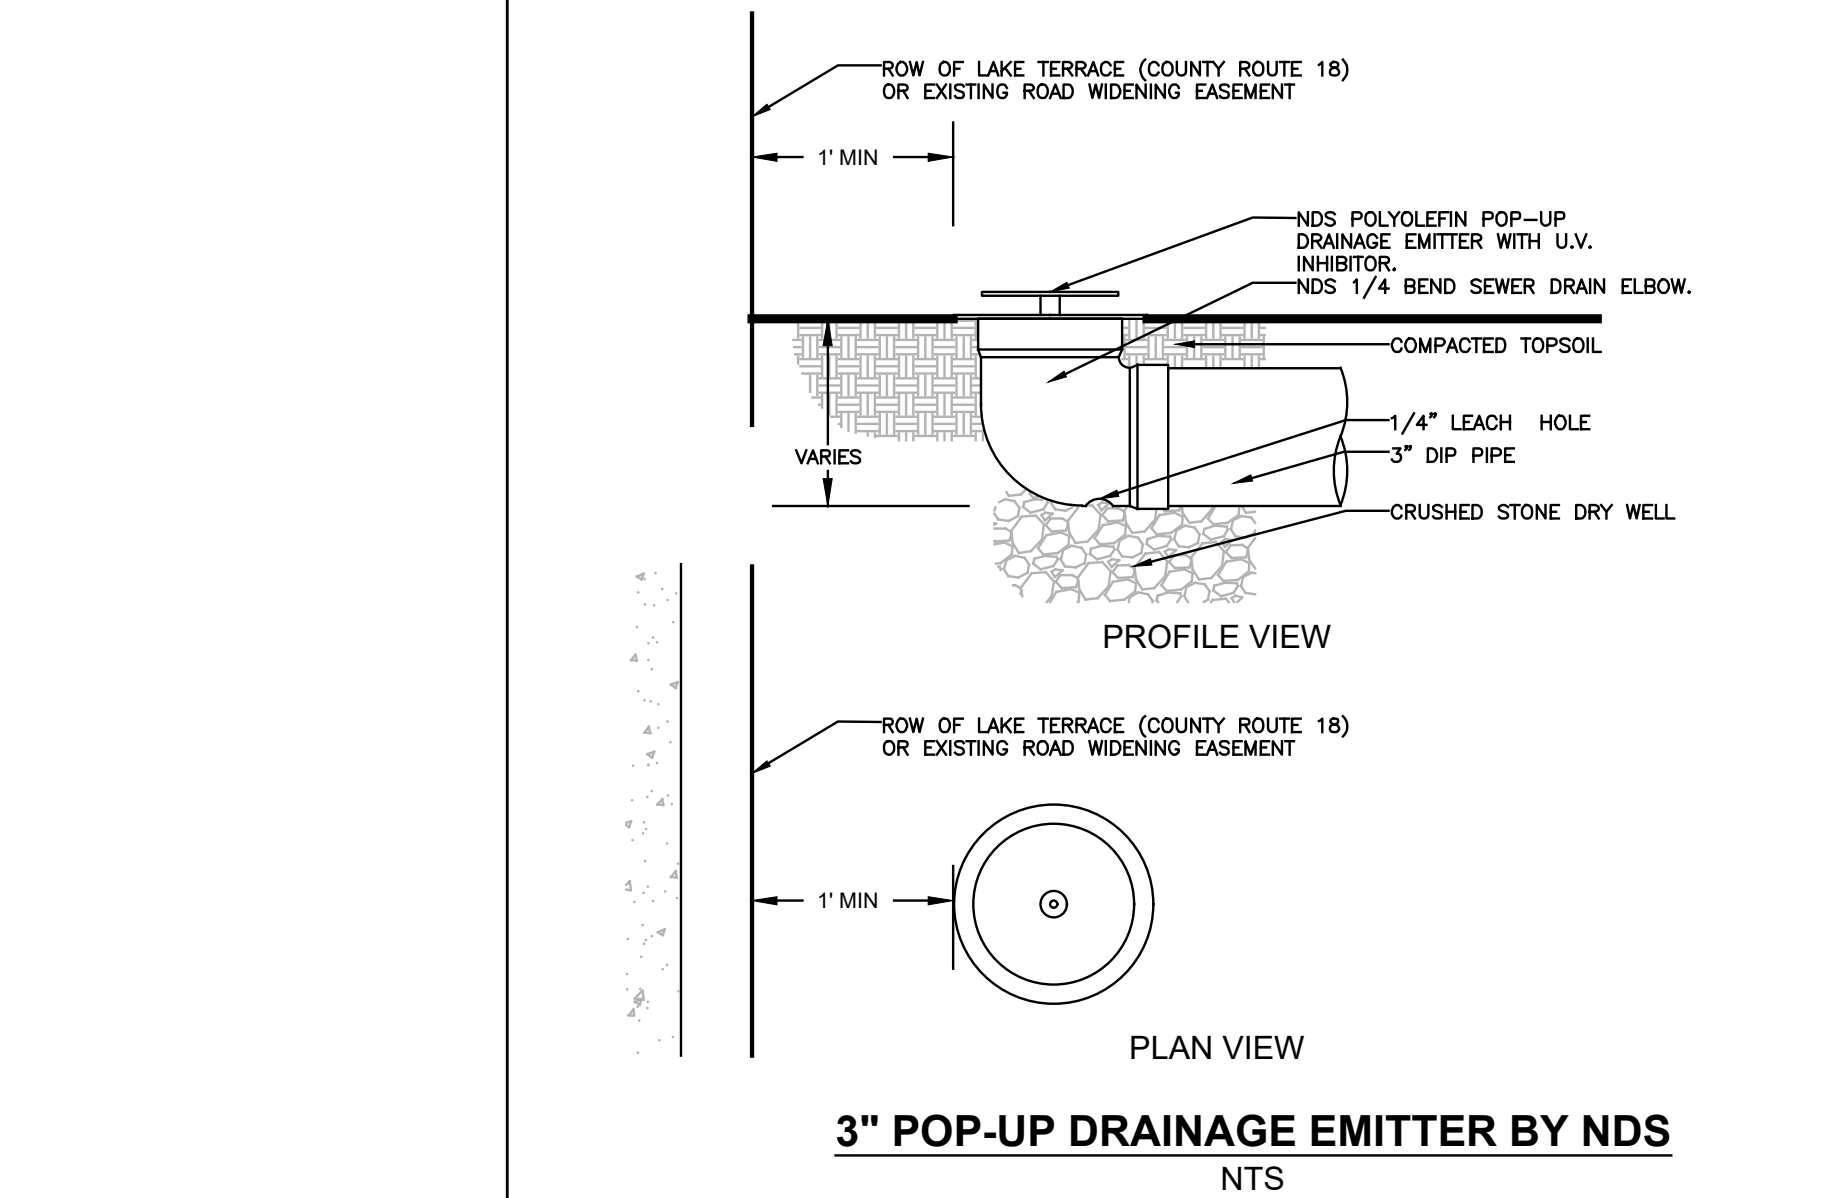
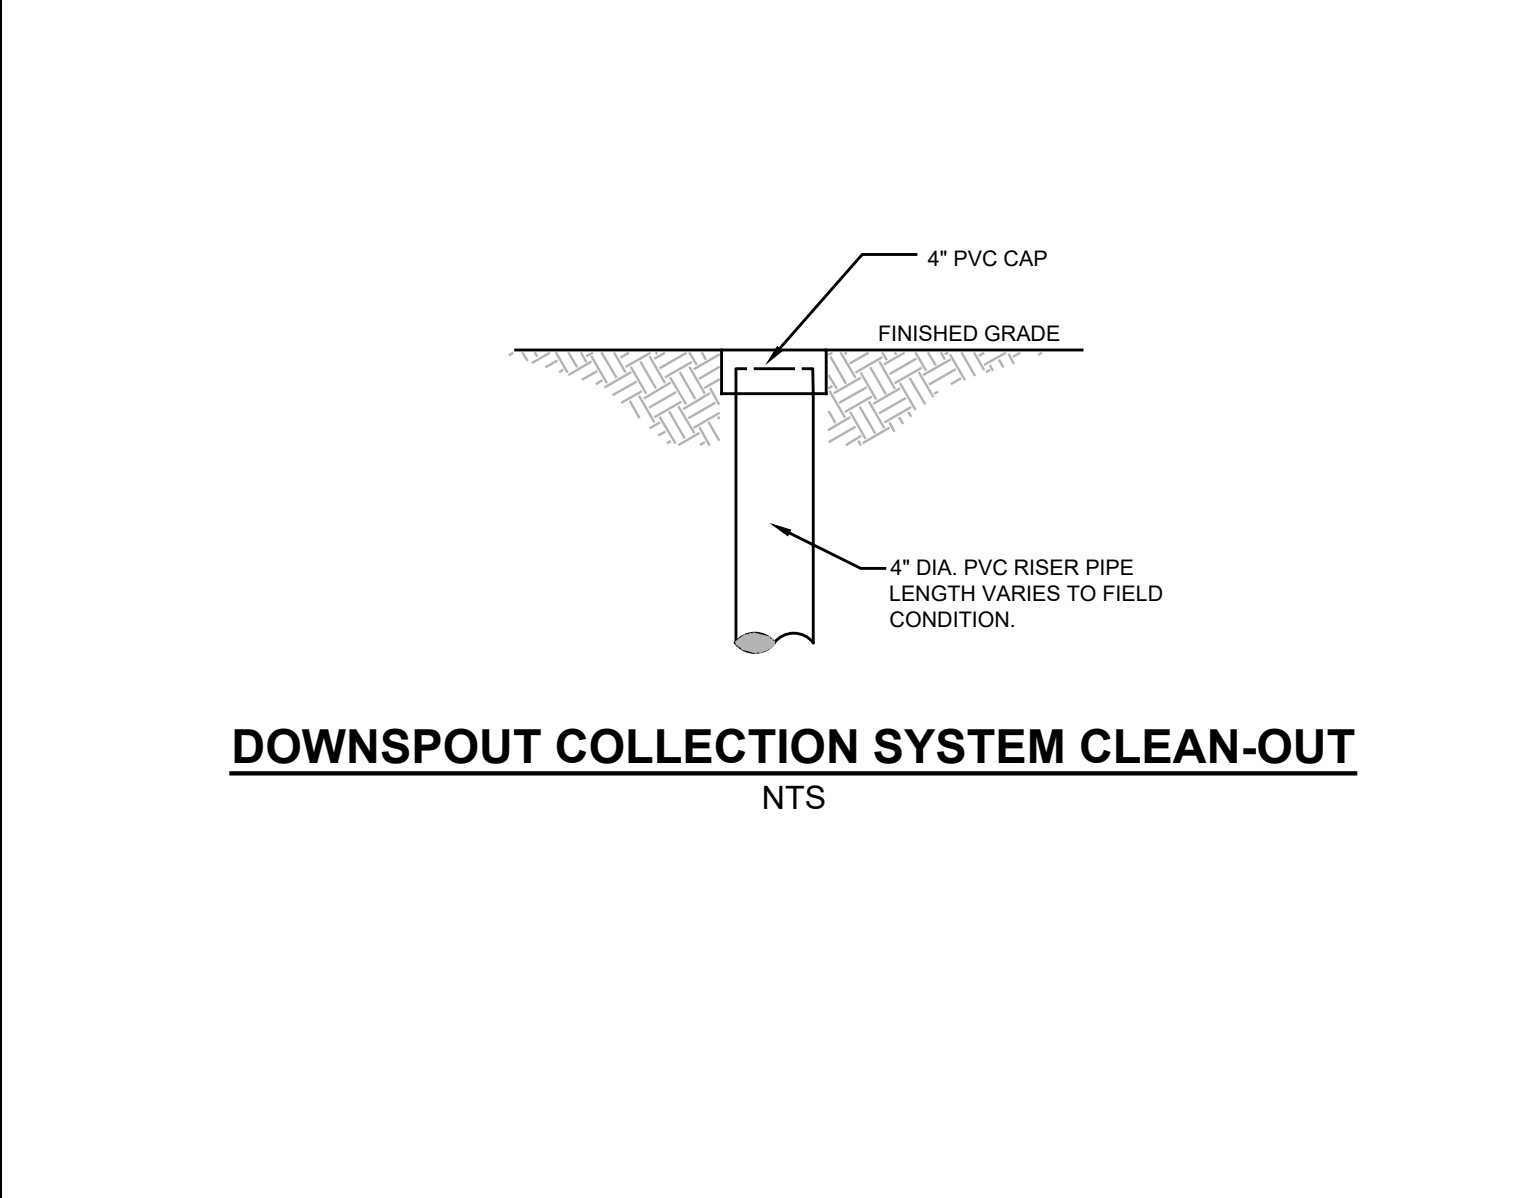
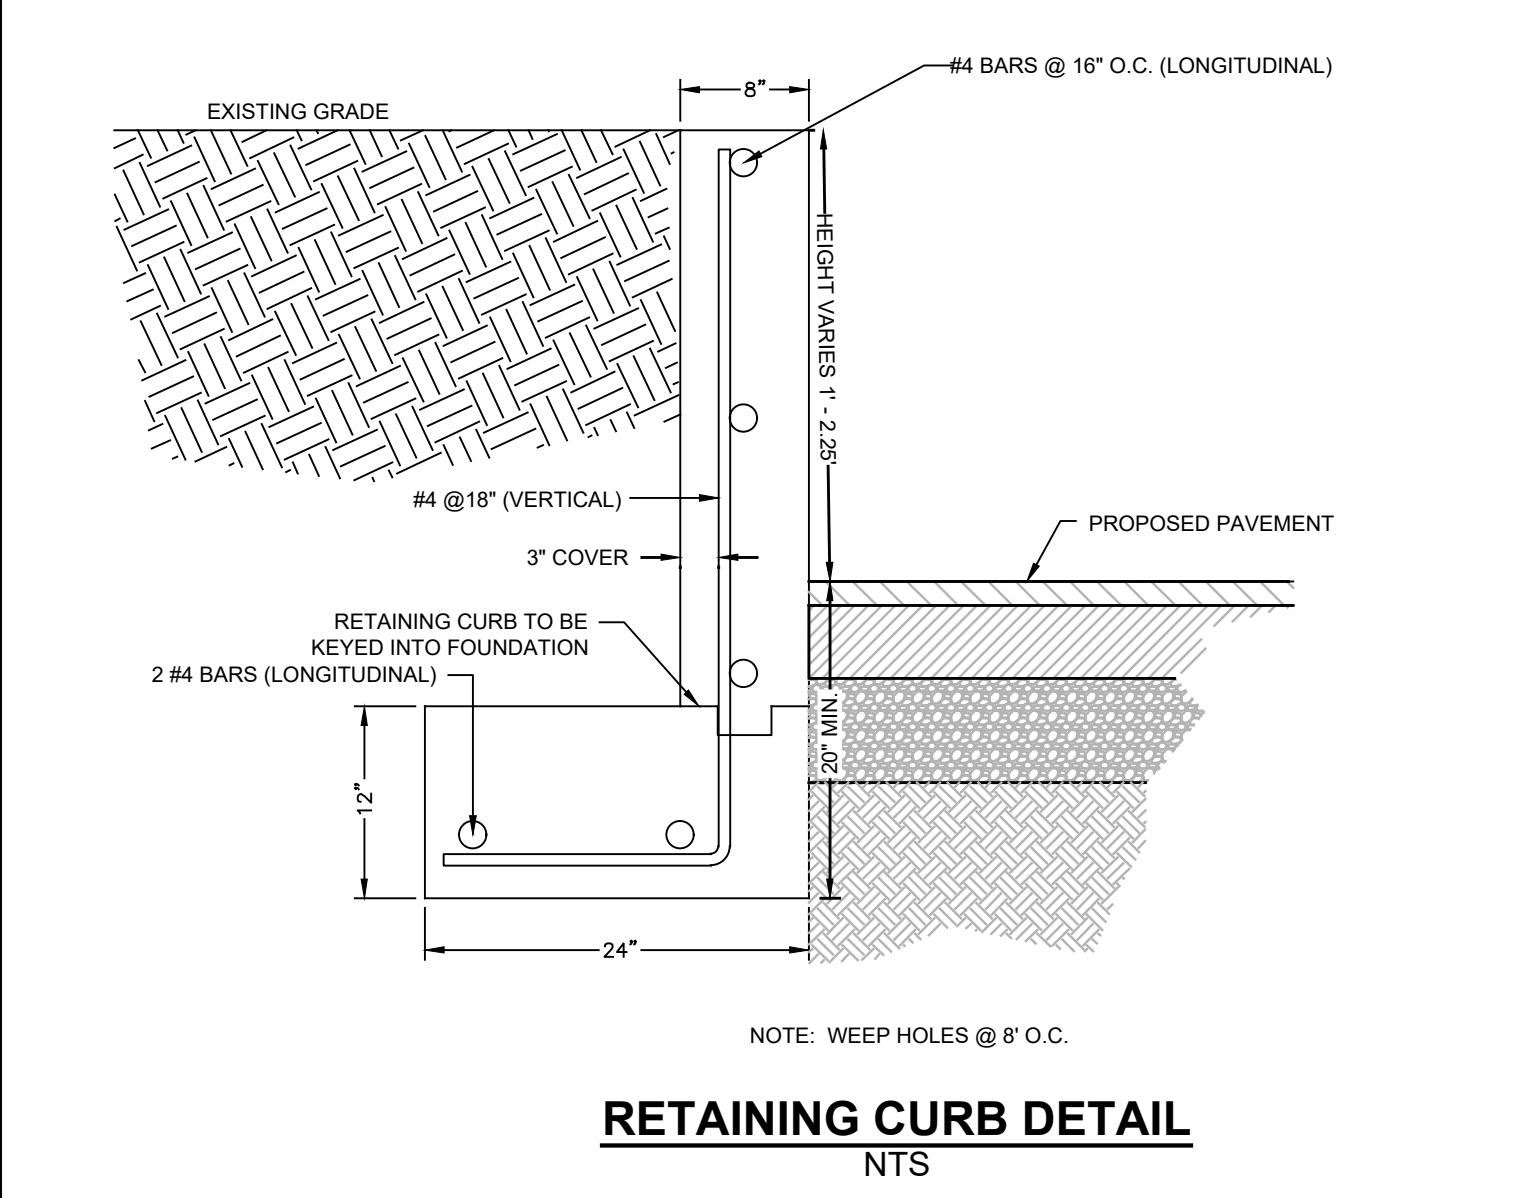
Drywell volume (perf pipe + stone)	Drywell volume (perf pipe + stone)	Drywell volume (perf pipe + stone)	Drywell volume (perf pipe + stone)
Perf pipe diameter 12 in Stone surround 6 in Length of pipe 90 ft trench dim's (square) 2.00 ft pipe diameter 1.00 ft pipe volume/LF 0.79 cf void ratio 0.40 stone volume/LF 1.29 cf	Perf pipe diameter 12 in Stone surround 6 in Length of pipe 275 ft trench dim's (square) 2.00 ft pipe diameter 1.00 ft pipe volume/LF 0.79 cf void ratio 0.40 stone volume/LF 1.29 cf	Perf pipe diameter 12 in Stone surround 6 in Length of pipe 340 ft trench dim's (square) 2.00 ft pipe diameter 1.00 ft pipe volume/LF 0.79 cf void ratio 0.40 stone volume/LF 1.29 cf	Perf pipe diameter 12 in Stone surround 6 in Length of pipe 310 ft trench dim's (square) 2.00 ft pipe diameter 1.00 ft pipe volume/LF 0.79 cf void ratio 0.40 stone volume/LF 1.29 cf
Total storage volume 186.41 cf	Total storage volume 569.59 cf	Total storage volume 704.22 cf	Total storage volume 642.08 cf

Total roof runoff volume 179.67 cf	Total roof runoff volume 563.76 cf	Total roof runoff volume 693.85 cf	Total roof runoff volume 625.66 cf
